LEVEL 1 REPLACEMENT RESERVE REPORT FY 2024 CAPE ST. CLAIRE IMPROVEMENT ASSOCIATION

CAPE ST. CLAIRE IMPROVEMENT ASSOCIATION

millerdodson
Capital Reserve Consultants

LEVEL 1 REPLACEMENT RESERVE REPORT FY 2024
CAPE ST. CLAIRE IMPROVEMENT ASSOCIATION

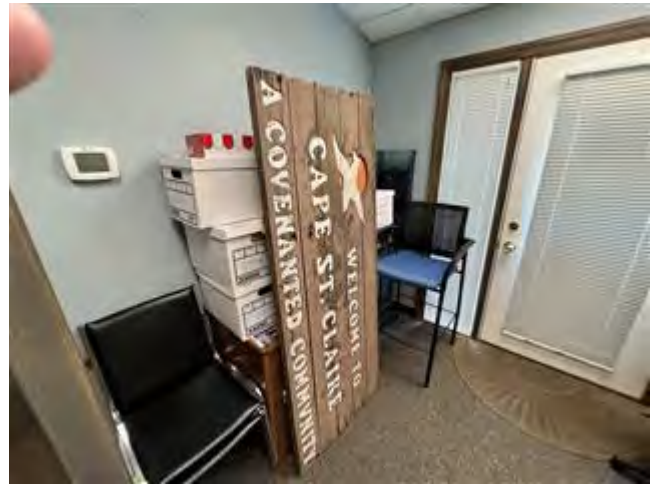
The entrance monument on Green Holly Drive is made of carved wood with pressure-treated bollard piers and appears to be in fair condition, with damaged areas and weathering. We recommend replacement every 10 to 15 years to keep the monument fresh and appealing. We also noted a wood monument sign inside the HOA office, which is not included in this study.

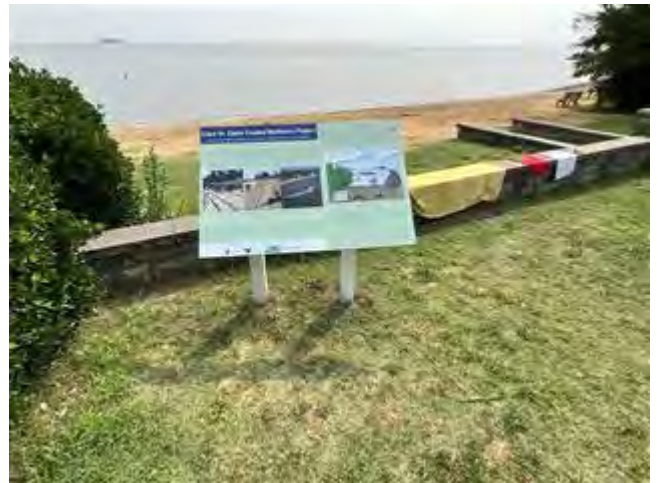
The monument at the clubhouse is made of plastic with pressure-treated bollard piers and appears in good condition.

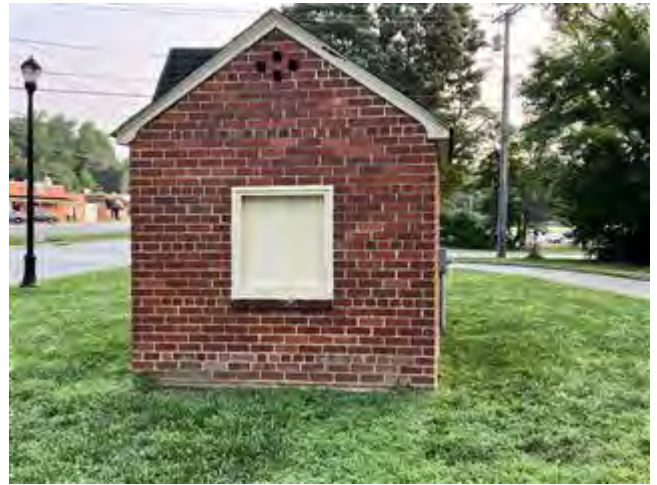
Gatehouse. The Association maintains a historic brick gatehouse. The Gatehouse's roof and structure appear in good condition, the door and windows appear in good condition, and the wood trim showed signs of deterioration and rot (see the Section on Building Exteriors). The interior was not observed. The masonry joints were found to be open in some areas, indicating water penetration into the masonry work, and graffiti is evident in some areas.

Brick masonry is used as the main exterior cladding of the building. As masonry weathers, the mortar joints will become damaged by water penetration. As additional water gains access to the joints, repeated freeze-thaw cycles gradually increase the damage to the mortar joints. If allowed to progress, even the masonry units, such as brick, can have their surfaces affected, and masonry units can become loose.

In general, masonry is considered a long-life item and is therefore excluded from reserve funding. However, because weather and other conditions result in the slow deterioration of the mortar in masonry joints, we have included funding in this study for repointing. Repointing is the process of raking and cutting out damaged sections of mortar and replacing them with new mortar.

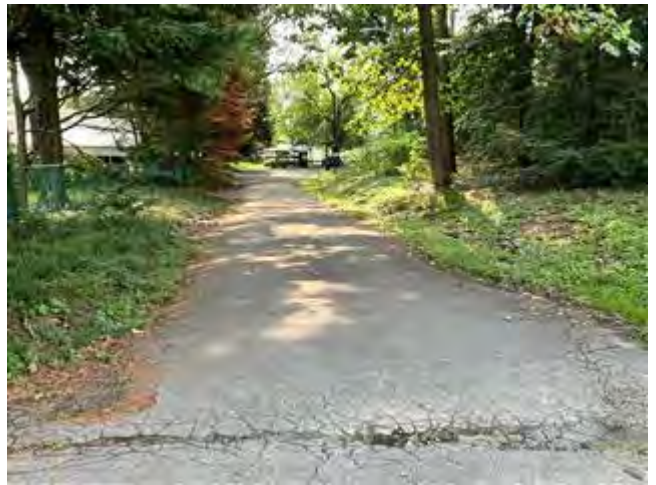
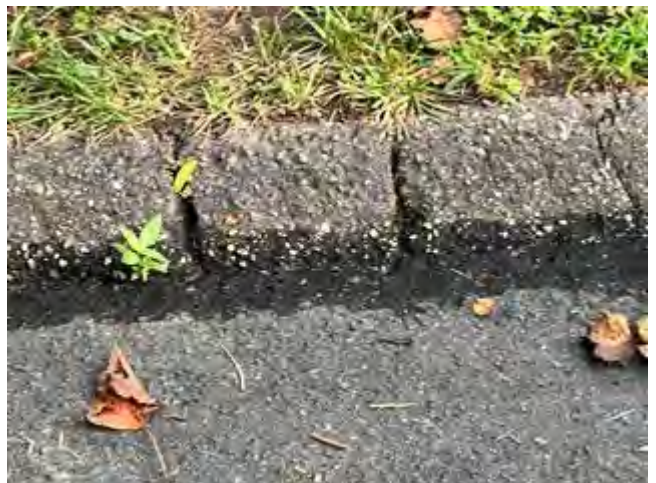
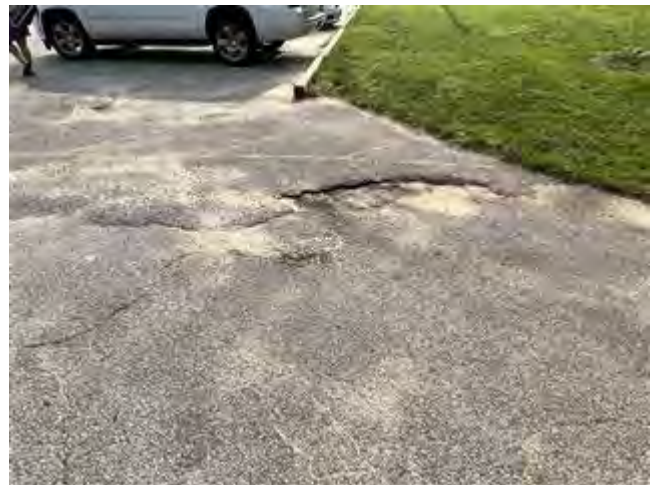
The Defects noted include the following:

As a rule of thumb, asphalt should be overlaid when approximately 5% of the surface area is cracked or otherwise deteriorated. The normal service life of asphalt pavement is typically 18 to 20 years. Research has shown if installed correctly and with proper maintenance and seal coating the first year and every five years thereafter, asphalt pavement can have a service life of up to 40 years or more.

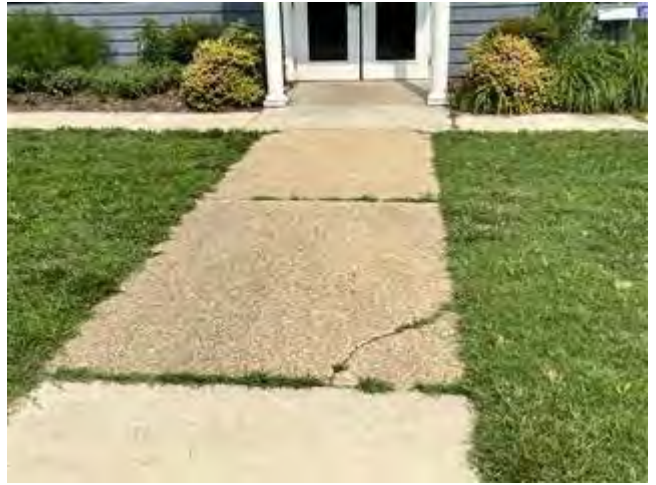
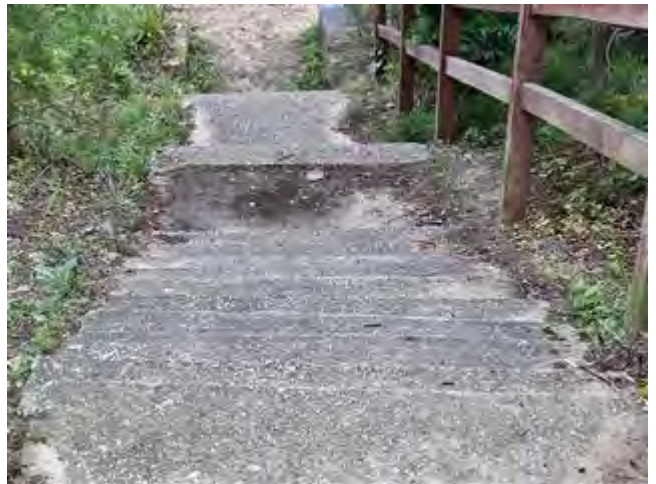
Concrete Work. The concrete work includes the community sidewalks, leadwalks, stairs, stoops, and other flatwork. The concrete work's overall condition appears to be fair, with areas of minor defects, including cracks and damage consistent with its age, that can usually be repaired by replacing the damaged sections. We have excluded the concrete stoops from valuation (below \$1,000). The concrete sidewalks at the clubhouse have a few cracked sections, and the stairs at Deep Creek have scaling. Scaling is the loss of surface cement, exposing the coarse aggregate.

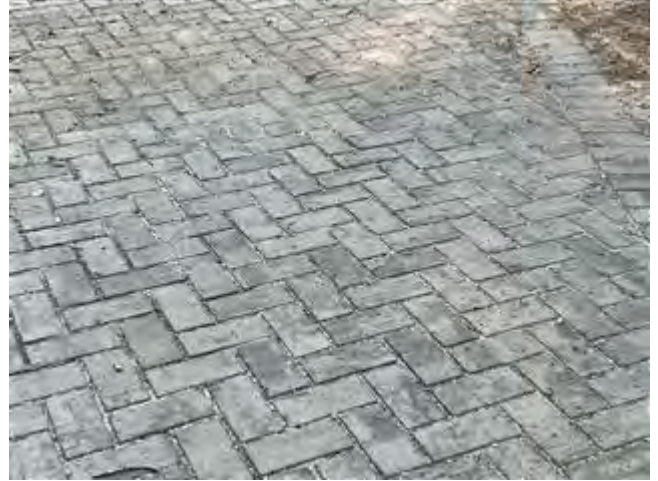
Brick Pavers. Brick pavers provide a solid, decorative, and renewable surface in the community's Main Beach Park. The overall condition of the brick pavers appears to be in good condition, with areas of defects noted.

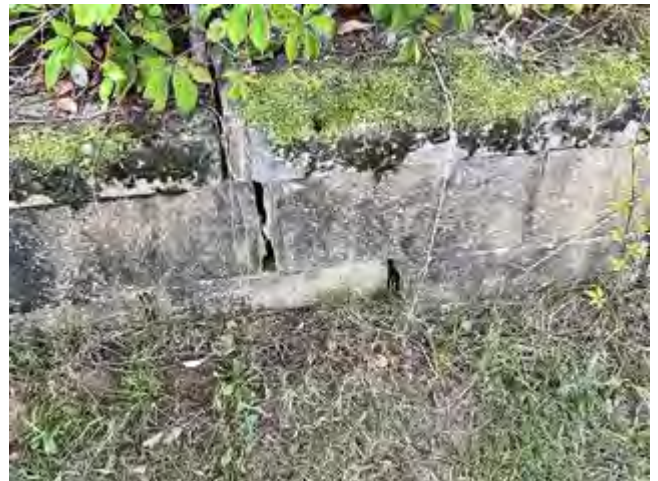
Retaining Walls. The Association maintains several wooden and masonry garden retaining walls. At Deep Creek, the wood retaining walls appear to be in mixed fair to marginal condition with light leaning, bowing, deterioration, or rot; the concrete masonry block garden retaining walls appear to be in poor condition with open masonry joints, and at the Main Beach, the segmental block masonry garden walls appear to be in good condition. There is also a large segmental block retaining wall at the shopping center, which is not included in the study.

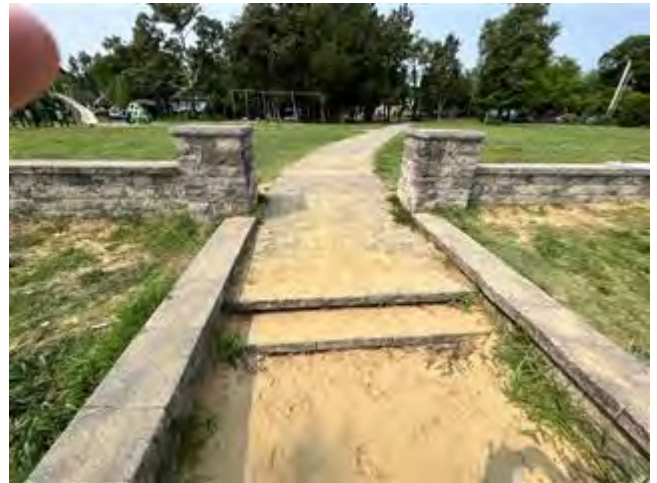
Segmental Block Retaining Walls. The Association maintains one segmental block retaining wall at the Main Beach. The retaining wall appears to be in excellent condition. The Association reports that one or two tiers of steps have been buried in the sand from the beach.

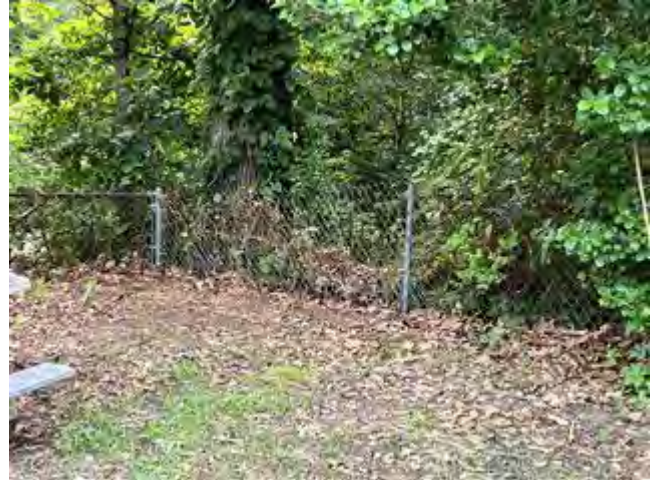
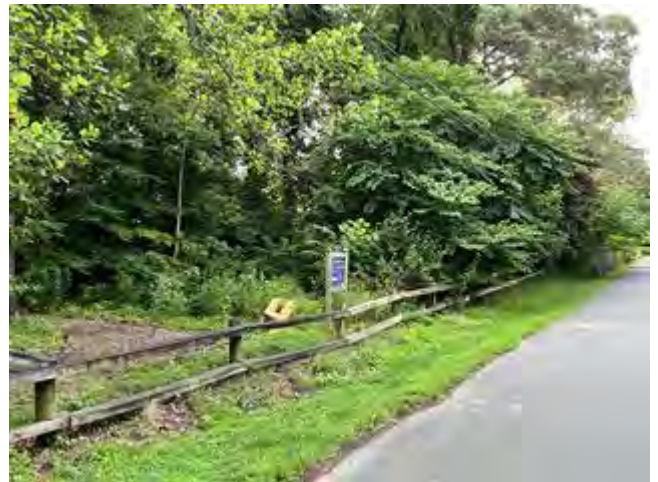
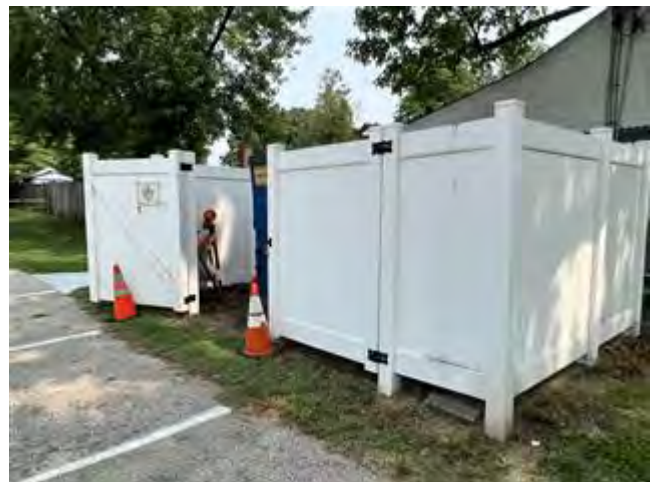
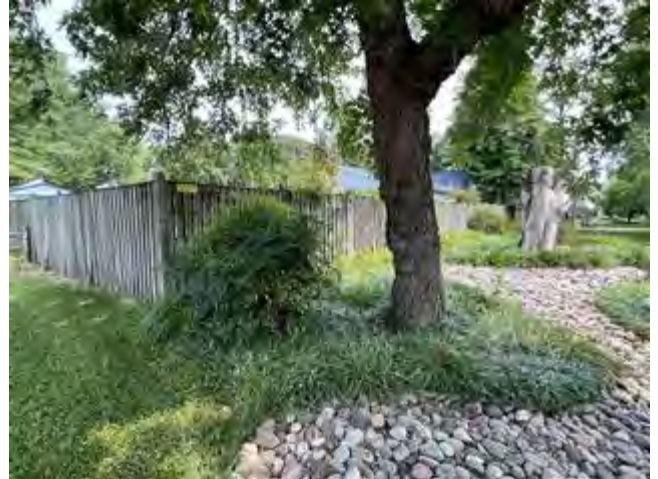
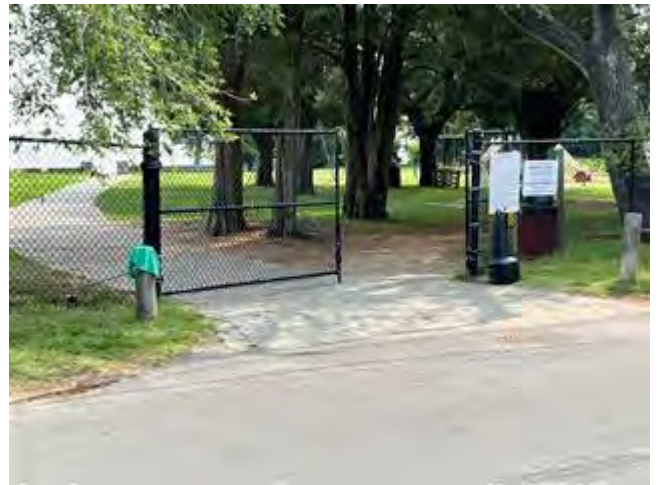
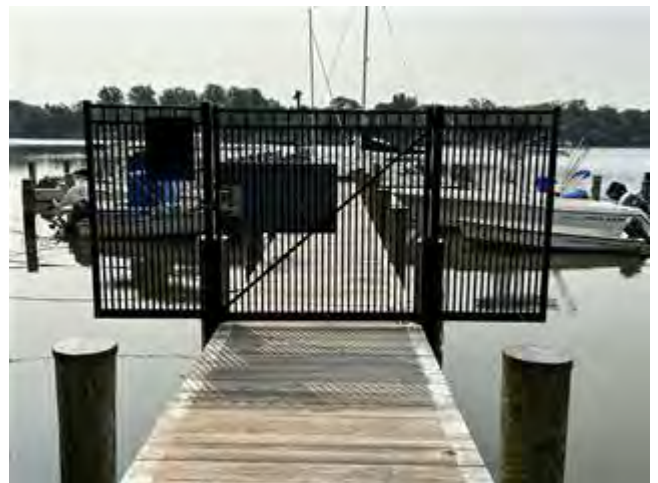
- Wood board appears to be in marginal to poor condition with areas of damaged fence boards or sections.
- Cable and chain bollard guardrail, which appears to be in poor condition.
- Vinyl-coated and galvanized chain links and gates appear to be in good to fair condition.
- Vinyl trash corrals and gates appear to be in good condition.
- Steel fence and gates at the piers appear to be in good condition.

Protection from string machine damage during lawn maintenance can extend the useful life of some fence types. Protection from this type of damage is typically provided by applying herbicides around post bases or installing protective sheathing.

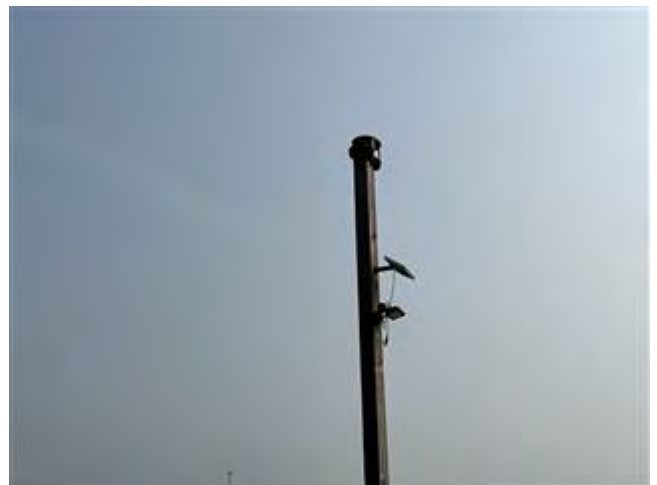
Site Lighting. The Association is responsible for operating the community's light poles, including the fishing pier plus the boat pier light poles funded under the Pier Committee sub-study, and ground-mounted floodlights at the entrance monument, all of which appear to be in fair condition. The lights were not on during our site visit, but we understand they remain in good operating condition. Ground-mounted site lights are excluded from valuation in the study.

This study assumes the replacement of the light fixtures every 15 to 20 years and pole replacement every 30 to 40 years. When the light poles are replaced, we presume the underground wiring will also be replaced.

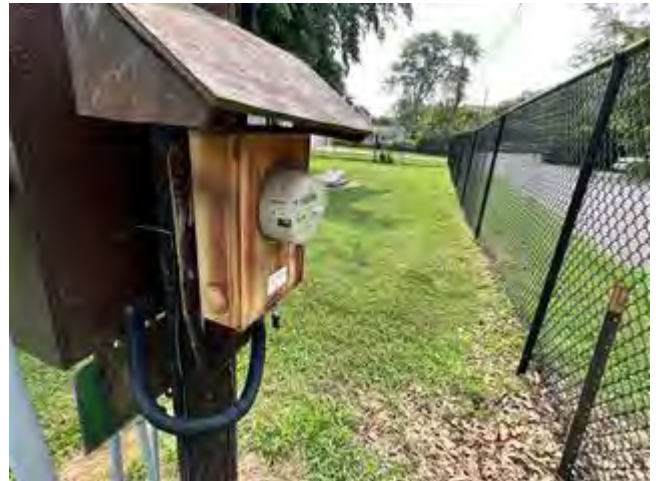
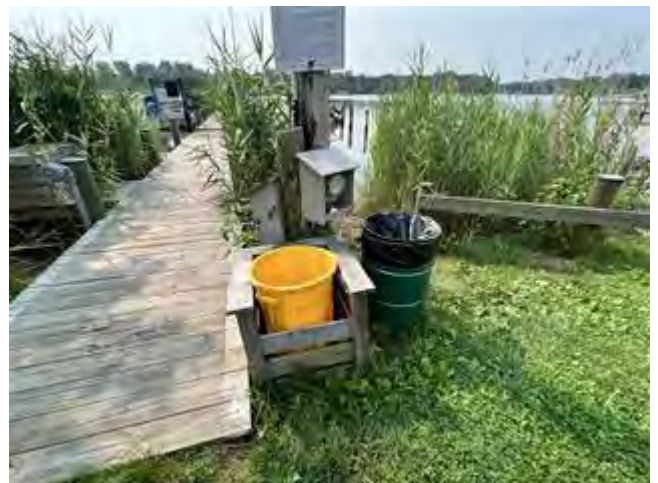
Electric Disconnect Stations. Electrical disconnect stations consist of simple circuit breaker boxes and meters to control and monitor site power and lights. The stations are exposed to weather elements and must eventually be replaced. Funding for future replacement has been programmed in the analysis.

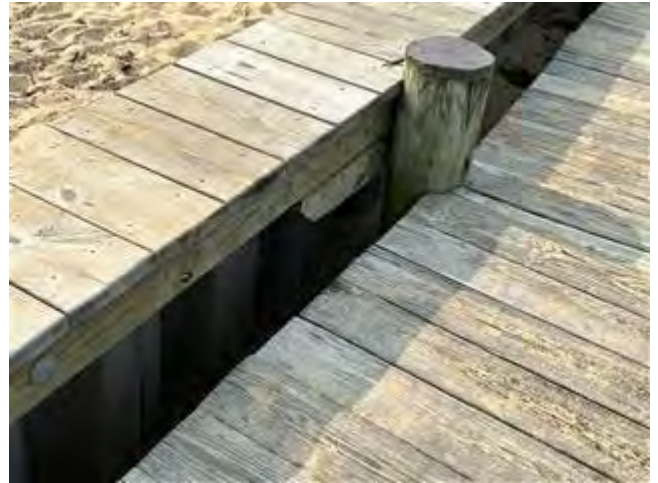
- **Bulkheads.** The Association is responsible for a concrete boat ramp with a wooden bulkhead at the Deep Creek piers that is funded in his study. The boat ramp, pier section, and bulkhead appear in fair condition. The vinyl baffle bulkhead at the Lake Clair boat pier is included in this study and appears to be in good condition, and it was installed around 2019. We have included funding in the Reserve Analysis for the periodic replacement of the boat ramp and these bulkheads. We could not observe the bulkheads below the waterline. The remaining boat pier sections and most of the wooden bulkhead are funded under the Pier Committee portion of the study. The Deep Creek pier bulkhead appears to be in mixed good to fair condition.

We recommend that the bulkheads be inspected at least once yearly and immediately following a storm that exposes the walls to significant wave action.

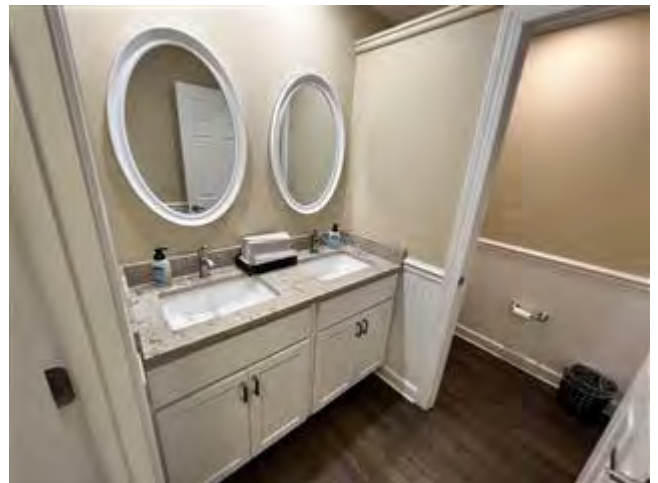
Interior Doors. The doors and frames are currently in good condition. Recommended maintenance includes inspecting all six sides of the door at least once a year and recoating the doors every five years or as needed to keep these doors in good shape for the lifetime of a building. We have not included interior doors in this study.
