LEVEL 1 REPLACEMENT RESERVE REPORT FY 2024 CAPE ST. CLAIRE IMPROVEMENT ASSOCIATION

CAPE ST. CLAIRE IMPROVEMENT ASSOCIATION

millerdodson
Capital Reserve Consultants

LEVEL 1 REPLACEMENT RESERVE REPORT FY 2024
CAPE ST. CLAIRE IMPROVEMENT ASSOCIATION

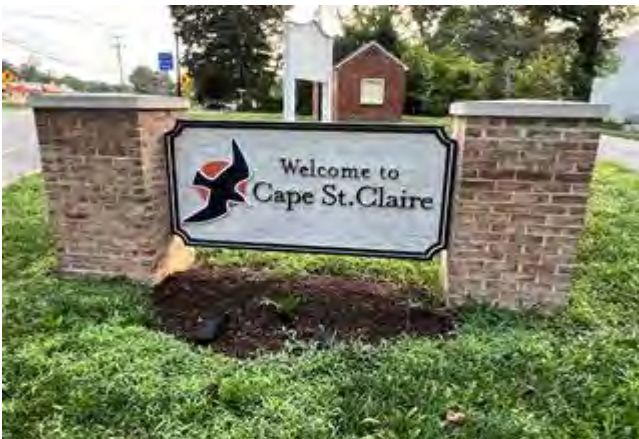
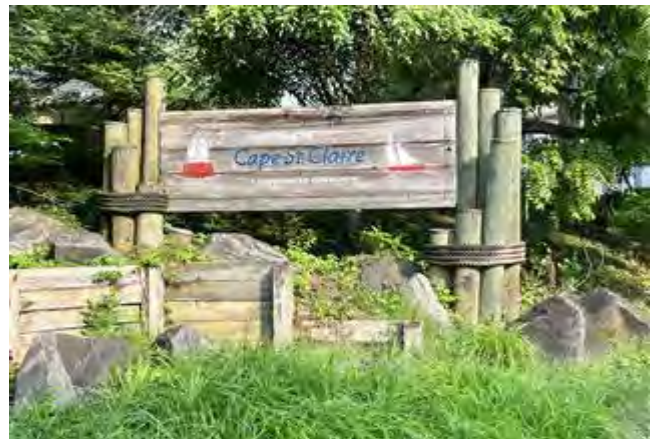
Entry Monument and Signage. The Association maintains entry monuments and monument piers. The Cape Saint Claire Road monument is made of a high-density urethane sign carved to appear like wood and brick piers with pier caps and appears to be in good condition.

We recommend repointing and replacement of defective areas of the masonry as needed. The Association may consider applying a coating of Siloxane or other appropriate breathable sealants to mitigate water penetration and further degradation of the masonry work. The Association may consider applying a sealer to the carved wood sign to mitigate water penetration and further degradation of the wood.

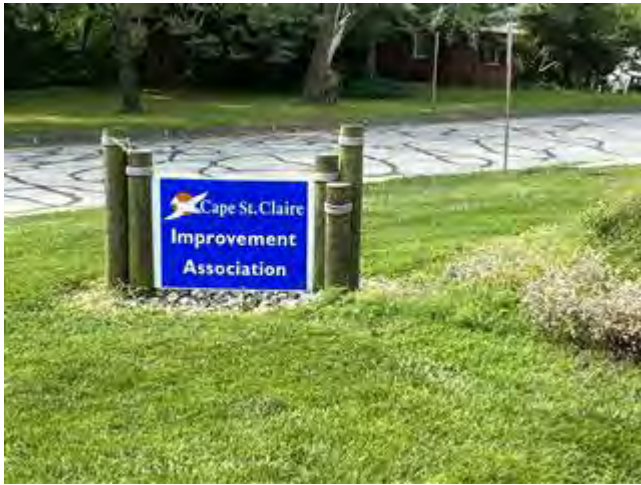
The entrance monument on Green Holly Drive is made of carved wood with pressure-treated bollard piers and appears to be in fair condition, with damaged areas and weathering. We recommend replacement every 10 to 15 years to keep the monument fresh and appealing. We also noted a wood monument sign inside the HOA office, which is not included in this study.

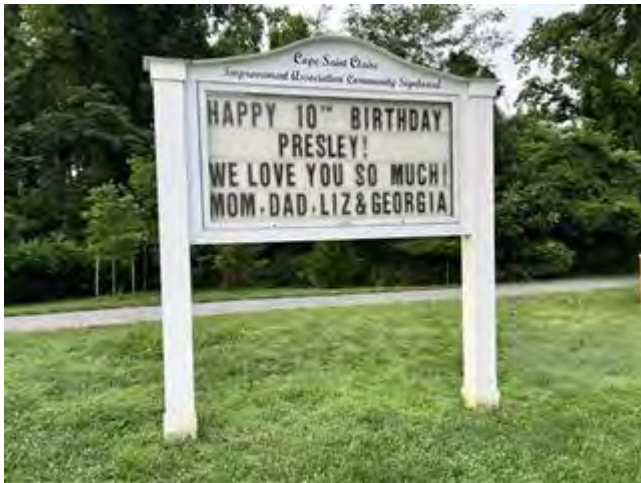
The monument at the clubhouse is made of plastic with pressure-treated bollard piers and appears in good condition.

In addition to monuments, the Association is responsible for community signage, including the community announcement board and informational placards. This study provides an allowance for 16 signs but does not consider other small miscellaneous signs that should be replaced using other funds.

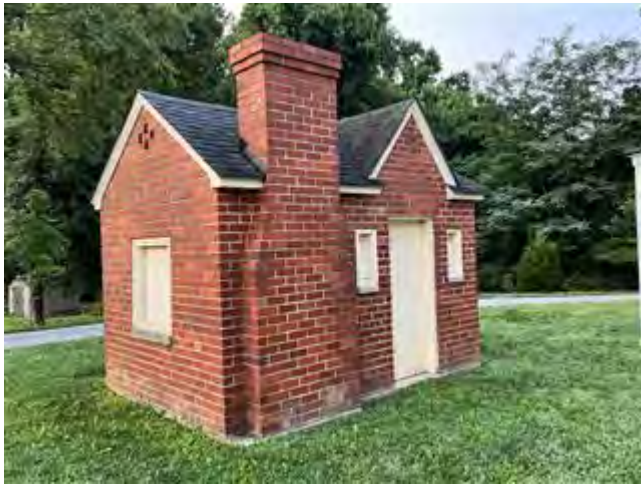
Gatehouse. The Association maintains a historic brick gatehouse. The Gatehouse's roof and structure appear in good condition, the door and windows appear in good condition, and the wood trim showed signs of deterioration and rot (see the Section on Building Exteriors). The interior was not observed. The masonry joints were found to be open in some areas, indicating water penetration into the masonry work, and graffiti is evident in some areas.

Brick masonry is used as the main exterior cladding of the building. As masonry weathers, the mortar joints will become damaged by water penetration. As additional water gains access to the joints, repeated freeze-thaw cycles gradually increase the damage to the mortar joints. If allowed to progress, even the masonry units, such as brick, can have their surfaces affected, and masonry units can become loose.

In general, masonry is considered a long-life item and is therefore excluded from reserve funding. However, because weather and other conditions result in the slow deterioration of the mortar in masonry joints, we have included funding in this study for repointing. Repointing is the process of raking and cutting out damaged sections of mortar and replacing them with new mortar.

Periodic repointing and local replacement of damaged masonry units will limit the damage done by moisture penetration. For this study, we assume that 10% of the masonry will require repointing every ten years after approximately 30 years.

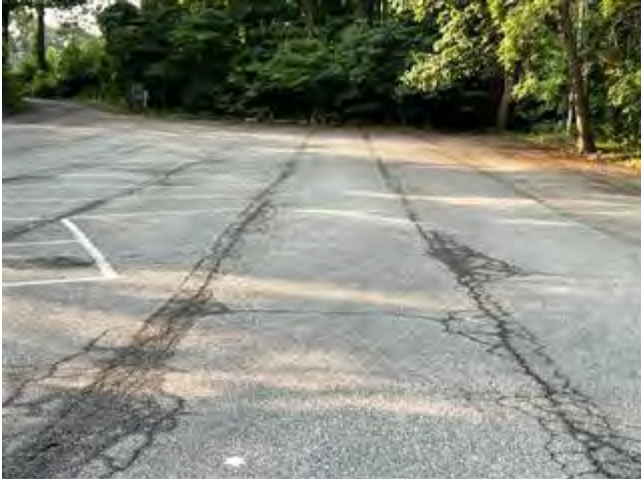
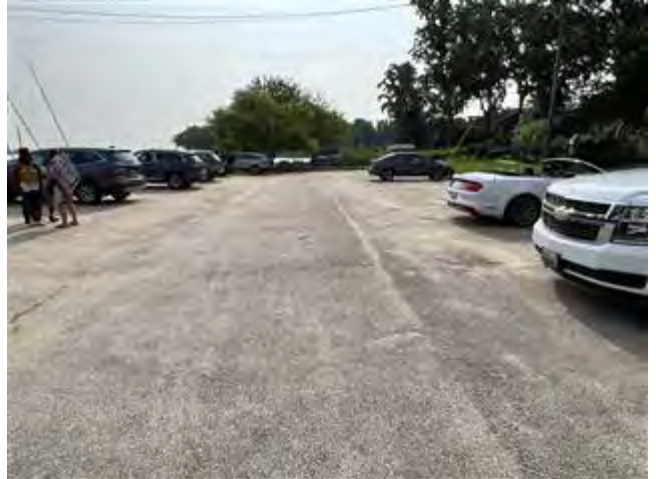
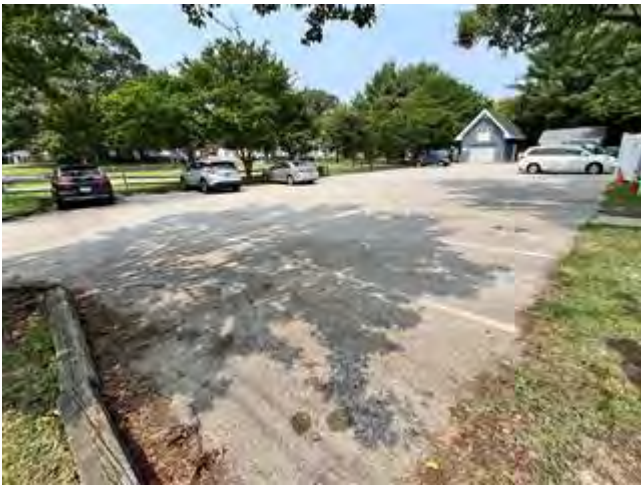
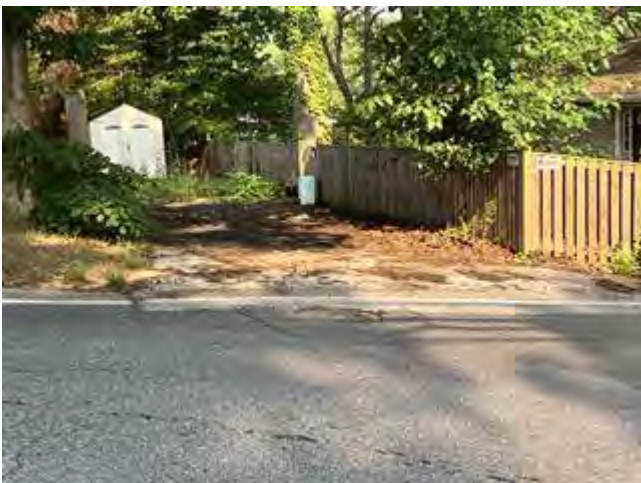
The Defects noted include the following:

- **Open Cracks.** There are multiple locations where open cracks allow water to penetrate the asphalt base and the bearing soils beneath. Over time, water will erode the base and accelerate the deterioration of the asphalt pavement. Remove the damaged areas and replace defective materials if cracks extend to the base and bearing materials. As a part of normal maintenance, clean and fill all other cracks.
- **Alligatoring.** There are multiple locations where the asphalt has developed a cracking pattern known as alligatoring. The primary cause of alligatoring is an unstable base. Once these cracks extend through the asphalt, they will allow water to penetrate the base, accelerating the rate of deterioration and eventually leading to

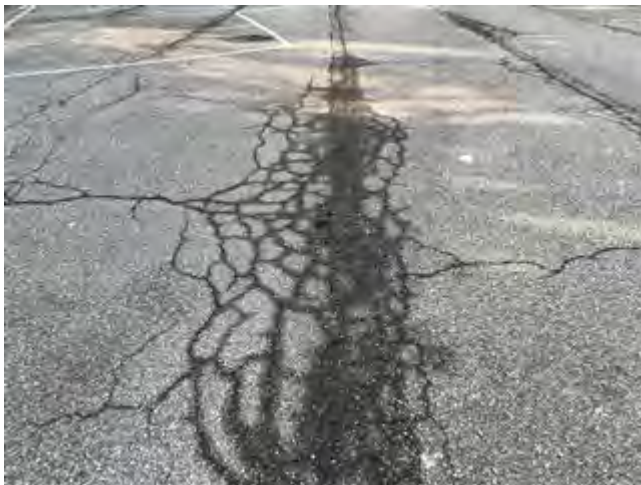
- **Edge Cracking.** Asphalt pavement sections have cracks along the edges due to improper confinement. Installation of curbs or installation of a compacted gravel shoulder at the time of an overlay project can address this defect.

As a rule of thumb, asphalt should be overlaid when approximately 5% of the surface area is cracked or otherwise deteriorated. The normal service life of asphalt pavement is typically 18 to 20 years. Research has shown if installed correctly and with proper maintenance and seal coating the first year and every five years thereafter, asphalt pavement can have a service life of up to 40 years or more.

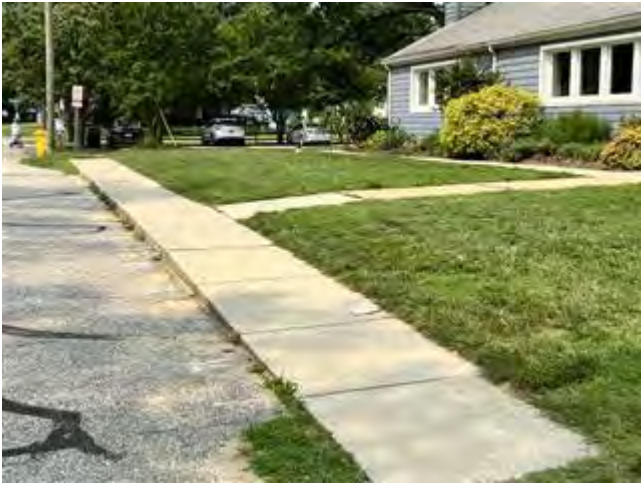
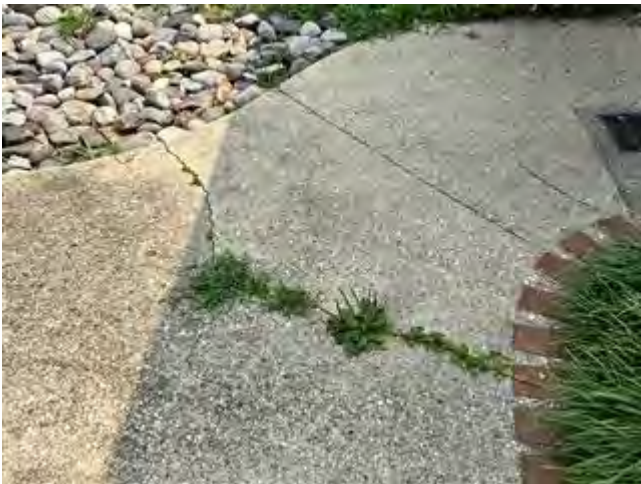
Concrete Work. The concrete work includes the community sidewalks, leadwalks, stairs, stoops, and other flatwork. The concrete work's overall condition appears to be fair, with areas of minor defects, including cracks and damage consistent with its age, that can usually be repaired by replacing the damaged sections. We have excluded the concrete stoops from valuation (below \$1,000). The concrete sidewalks at the clubhouse have a few cracked sections, and the stairs at Deep Creek have scaling. Scaling is the loss of surface cement, exposing the coarse aggregate.

- Trip hazard, ¼ inch height difference.
- Severe cracking.
- Severe spalling and scale.
- Uneven riser heights on steps.
- Steps with risers over 8¼ inches.

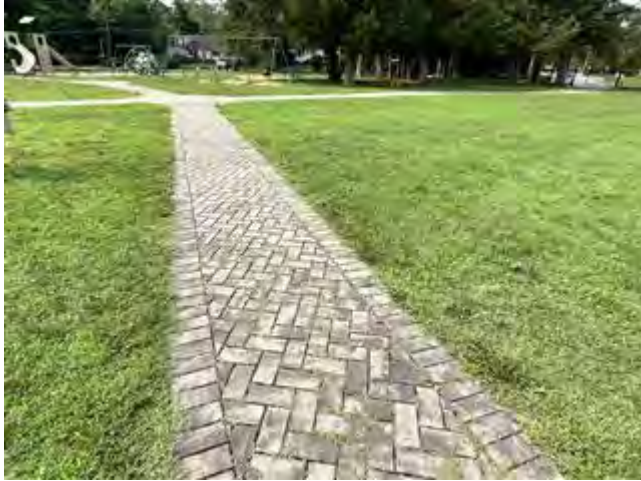
Brick Pavers. Brick pavers provide a solid, decorative, and renewable surface in the community's Main Beach Park. The overall condition of the brick pavers appears to be in good condition, with areas of defects noted.

- **Missing aggregate.** In areas where aggregate is missing from the joints between paver units, adding fine aggregate effectively reduces the amount of base soil removed due to water penetration.

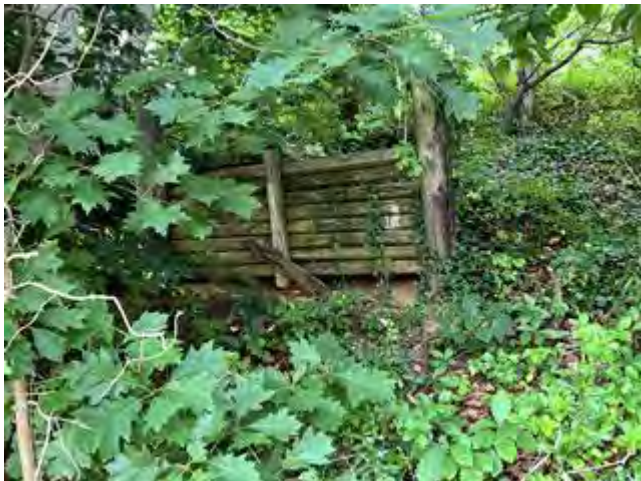
Retaining Walls. The Association maintains several wooden and masonry garden retaining walls. At Deep Creek, the wood retaining walls appear to be in mixed fair to marginal condition with light leaning, bowing, deterioration, or rot; the concrete masonry block garden retaining walls appear to be in poor condition with open masonry joints, and at the Main Beach, the segmental block masonry garden walls appear to be in good condition. There is also a large segmental block retaining wall at the shopping center, which is not included in the study.

Concrete Block. Concrete block masonry walls can have an extended useful life of 40 years or more and, if stable, may only require periodic re-pointing and localized repair. Repoint is raking out defective masonry joints and tooling new mortar into the joints. Properly mortared and tooled joints will repel the weather and keep water from penetrating the wall. Siloxane or other breathable sealants should be considered to protect the wall from water penetration. This study assumes that re-pointing will be performed incrementally as needed to maintain the life of the wall.

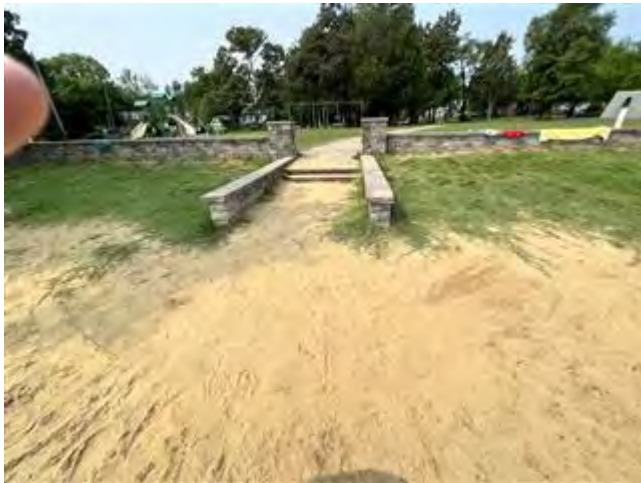
Segmental Block Retaining Walls. The Association maintains one segmental block retaining wall at the Main Beach. The retaining wall appears to be in excellent condition. The Association reports that one or two tiers of steps have been buried in the sand from the beach.

Segmental block retaining walls can have an extended useful life and, if stable, are likely to only require localized resetting of displaced blocks, typically near the top of the wall. This study assumes that resetting will be performed incrementally as needed. Segmental block retaining walls can have a service life of 80 years or more.

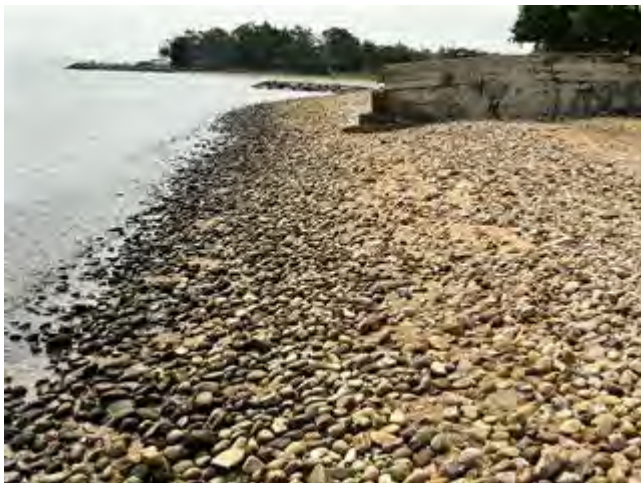
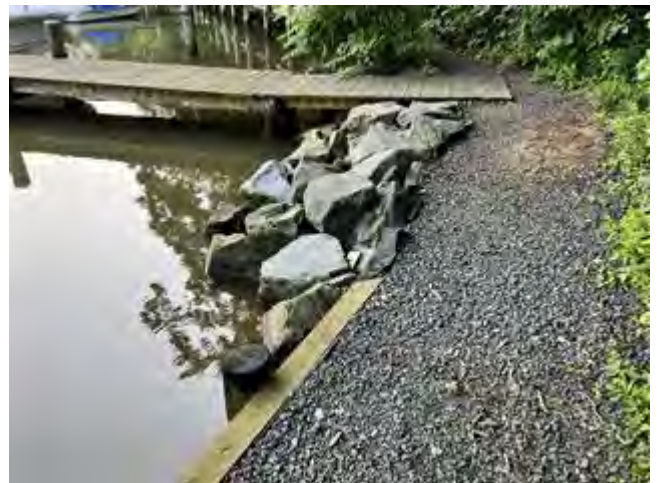
- **Shoreline Revetments.** The community's Main Beach Park recreation area has a shoreline permeable stone revetment called a cobble bar installed in 2021-2022, and the Association is responsible for its management and maintenance. The revetment consists of cobblestones designed to reduce beach erosion and absorb wave action. We noted some disbursement of the stones, which apparently is by design. The Deep Creek pier has several areas of permeable armor stone revetment with geotextile and core riprap that appear in good condition, with other areas in poor condition with noted gaps.

Because it is highly unlikely that all of the stone revetment components will fail and require replacement in the study period, we have programmed funds to replace 10% of these inventories every 20 years to spread the funds over an extended timeframe to reflect the incremental nature of this work. Based on the Association's experience, future reserve studies should adjust these allowances.

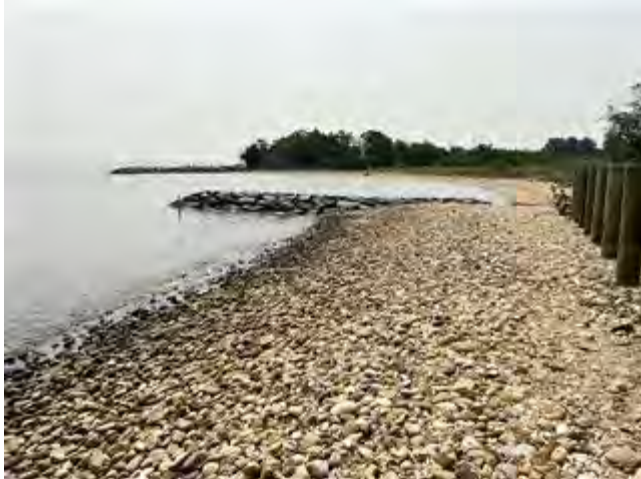
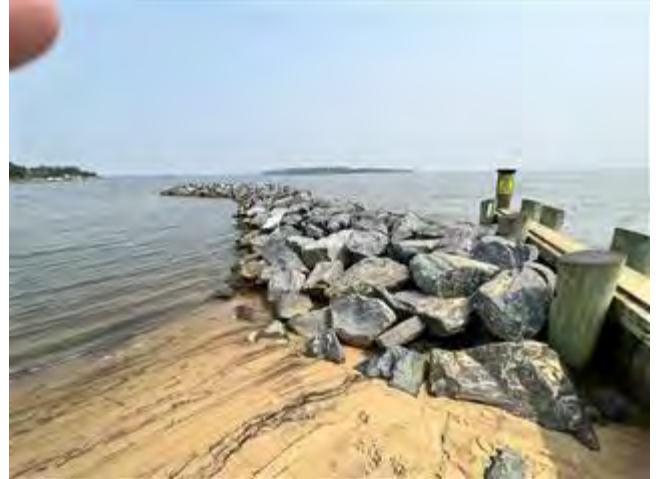
The Association maintains three groins at the Main Beach Park recreation area, which occurs at the shoreline facing the Chesapeake Bay. The groins appear to be in good condition.

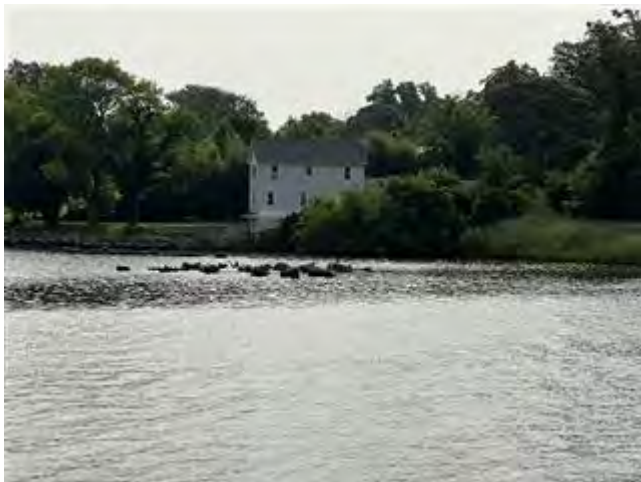
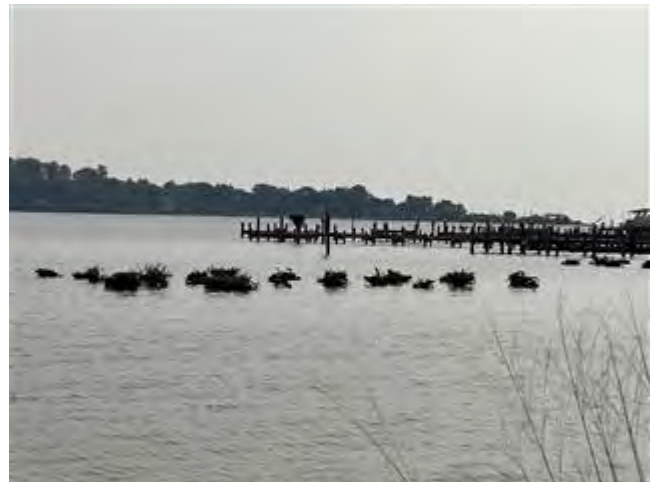
- **Breakwaters.** The Association maintains an oyster reef ball and inverted root wad field at Lake Claire to reduce wave action and beach erosion of the beach barrier at Lake Claire. These controls act more like natural barriers and are less damaging than armor barriers such as bulkheads. The oyster reef balls are submerged and unobserved, and the inverted root wads appear in good condition.

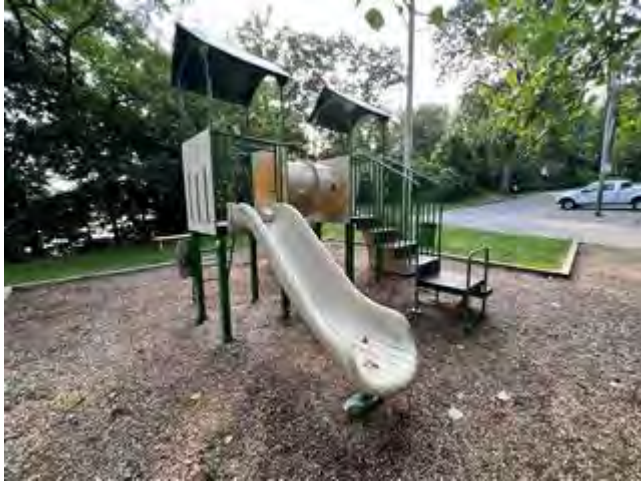
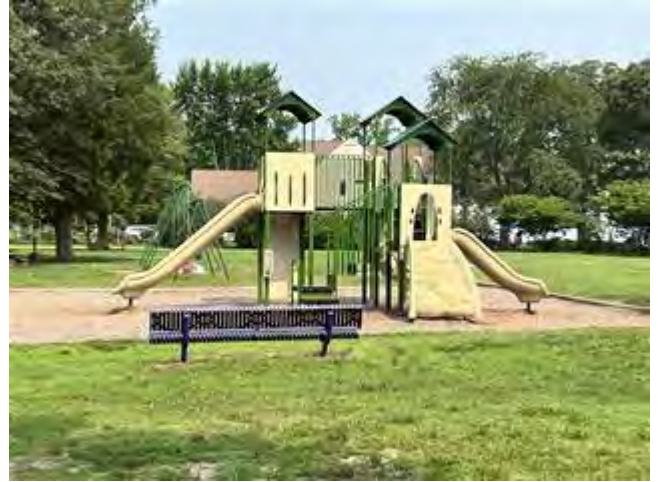
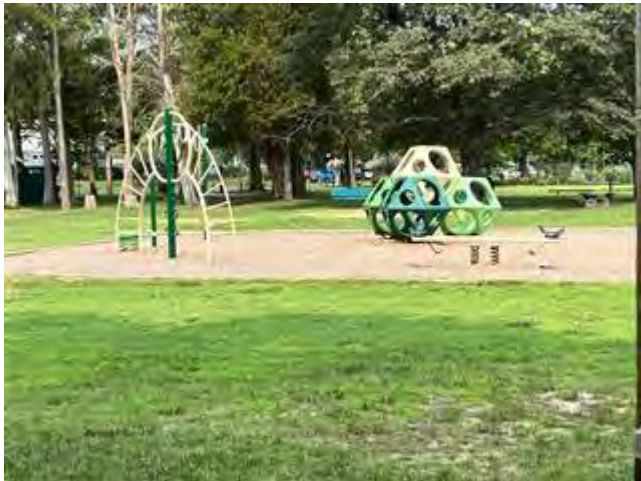
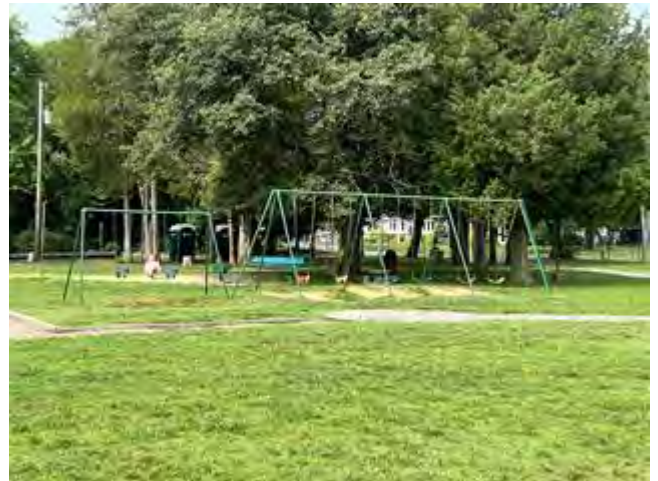
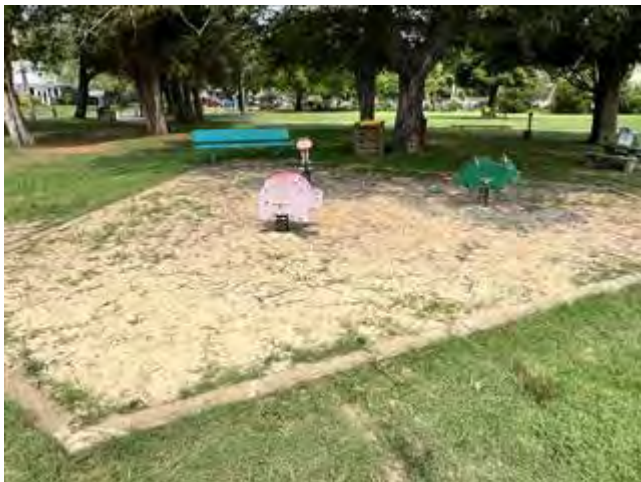
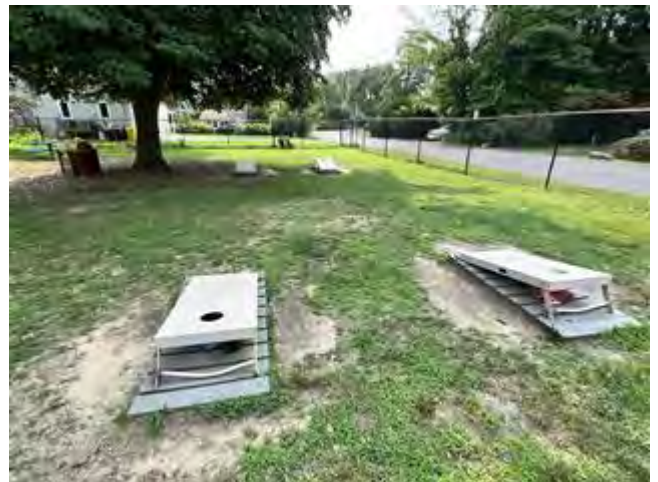
Playgrounds. The community maintains two playgrounds, one at Deep Creek and the other at the Main Beach. These playgrounds include play structures, miscellaneous play equipment, wood borders, and a wood chip surface. The facilities appear to be in generally good condition with minor wear. The wood chip surface is displaced, missing, and does not appear to be adequate. [09/30/2023] revised per board

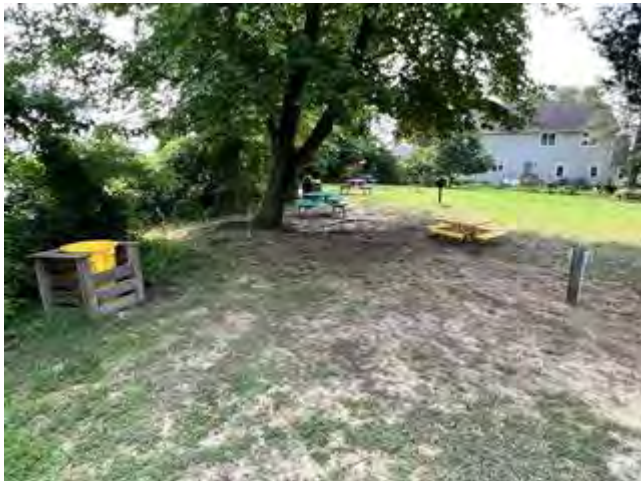
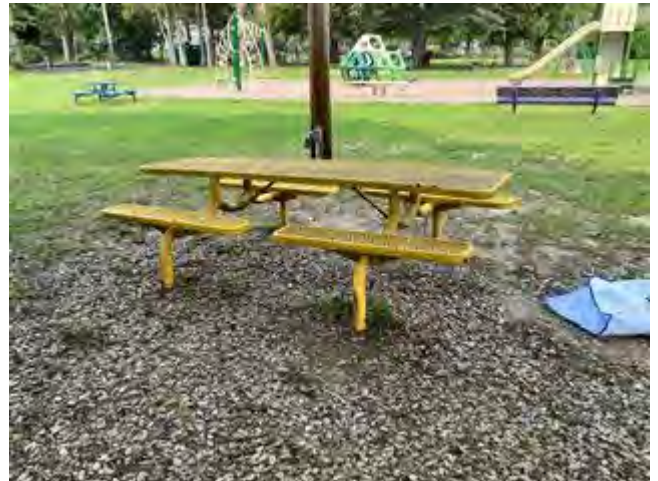
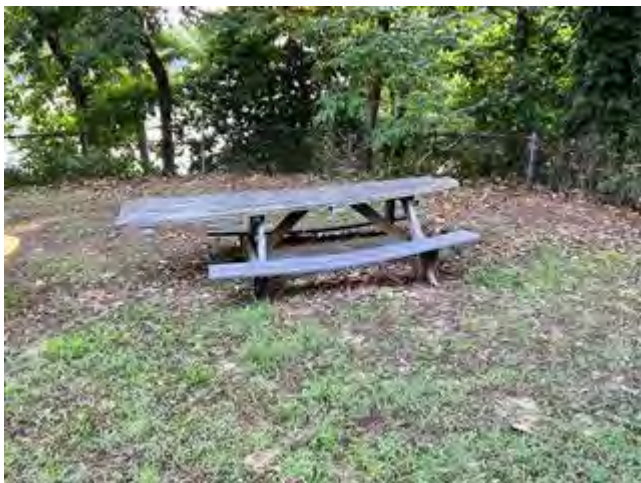
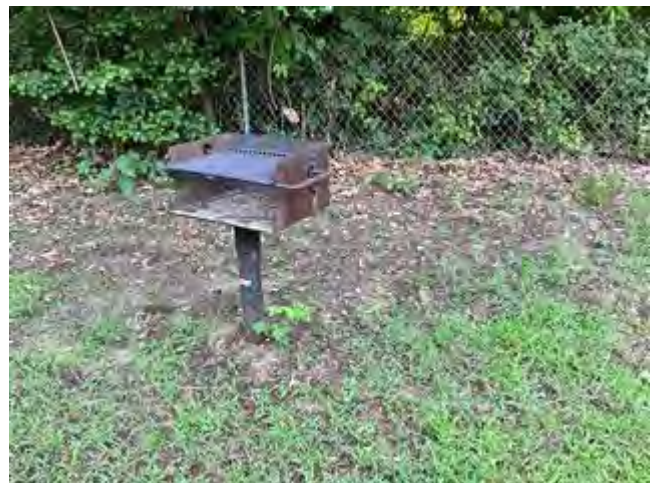
- Picnic tables: The picnic tables appear to be in mixed condition.
- Benches: The benches appear in fair condition, with some noted weathering.
- Park grills: The park grills appear to be in fair condition.
- Trash and recycling receptacles: The coated metal trash receptacles appear in good to fair condition, and the wooden recycling corrals appear in good condition.
- Plastic dog waste stations: The dog waste stations appear to be in fair condition, although it is noted that none have trash receptacles.
- Bike racks: The bike racks appear to be in good condition.

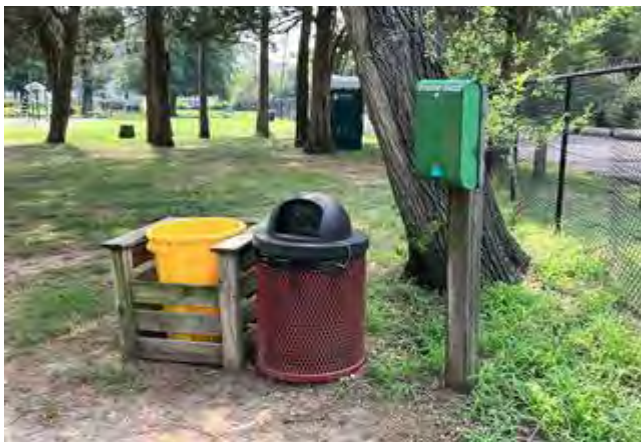
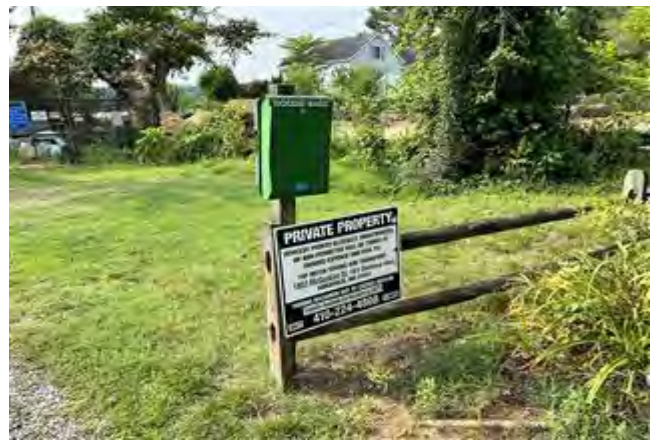
Trash Cans. The community maintains perforated metal trash cans that appear in good to fair condition.

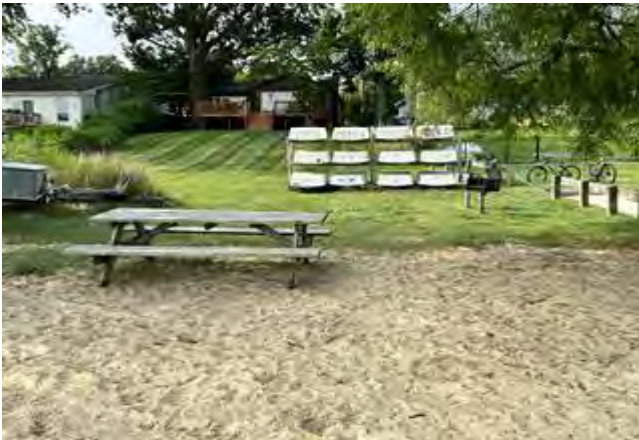
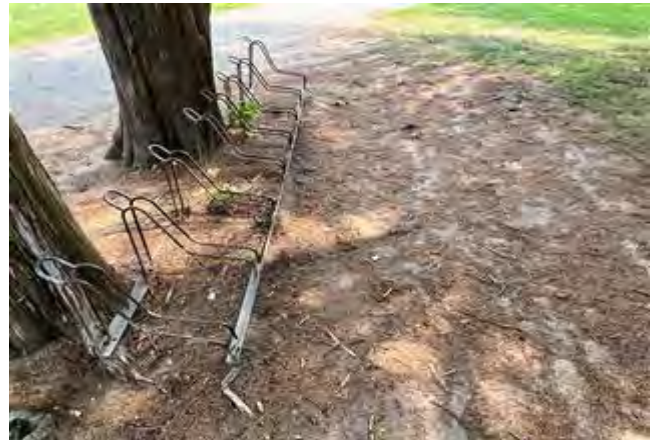
Bike Racks. The community has two bike racks that appear to be in good condition.

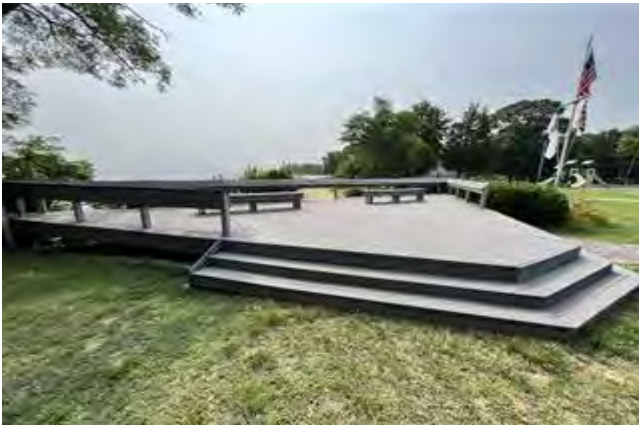
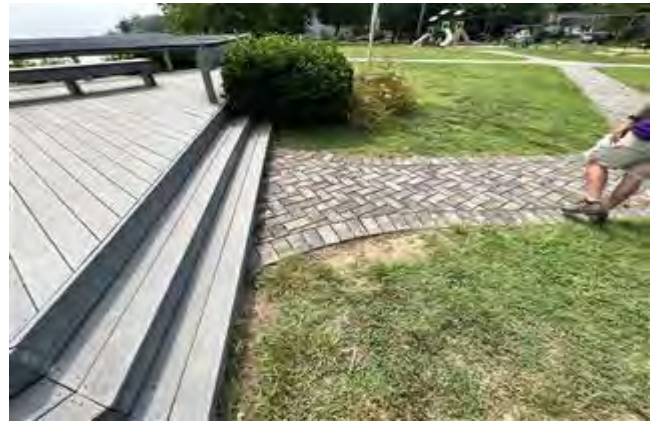
Decks. The Association maintains the wooden and composite deck of the community Main Beach area. The wooden deck structures appear to be in good condition, with the composite decking and the composite railings appearing to be in excellent condition.

We recommend that the Association implement an annual inspection program. We also recommend power washing every two to three years. Installation of carpet or other water-trapping coverings should be prohibited, and potted plants should be placed on raised feet to allow for proper air circulation and drying of wooden components.

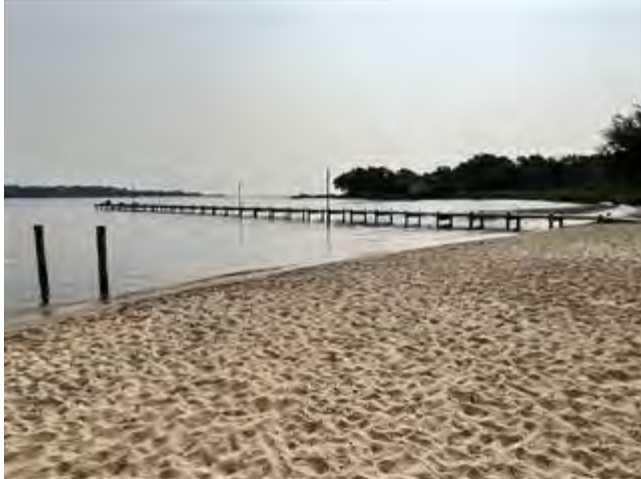
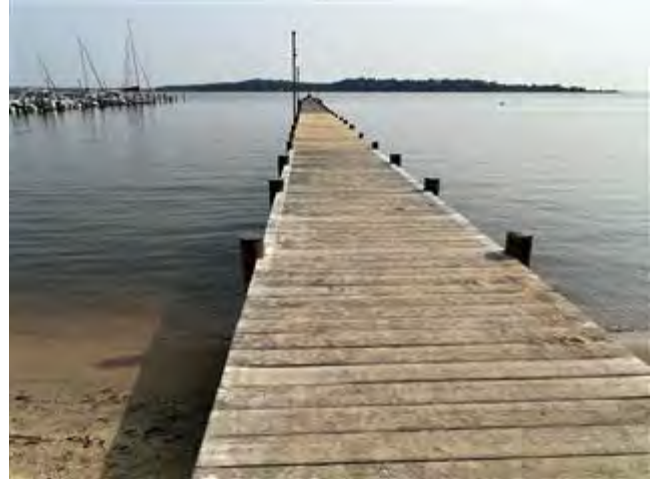
Wood Piers. The Association operates one wood fishing pier. The pier is constructed from pressure-treated lumber supported by wood pilings. The pier is over 30 years old. We presume new pier surfaces and railings were installed approximately ten years ago for the study. The other piers are funded under the Pier Committee study that follows this study.

The wood pier decking appears to be in good condition.

The pier structure appears to be in good condition.

It is recommended that all piers be inspected at least once each year to identify damage to pilings, structural members, surface boards, and railings.

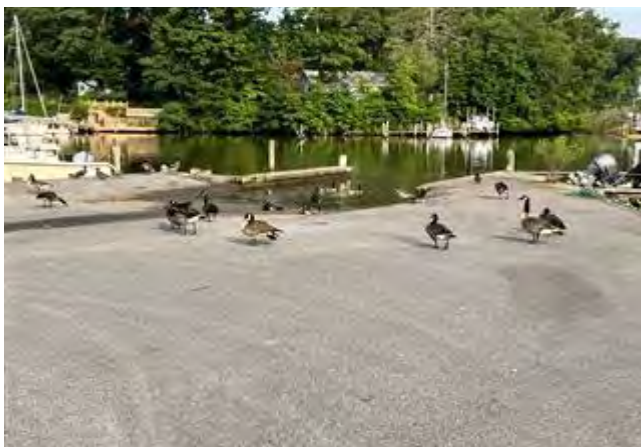
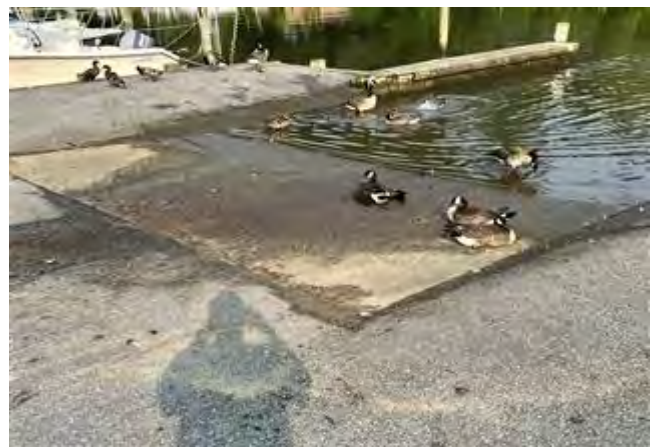
Boat Ramp. The Association maintains approximately 700 square feet of concrete boat ramp at the Deep Creek pier area. The Boat Ramp is constructed of poured concrete. The Boat Ramp's age is unknown and it appears in fair condition.

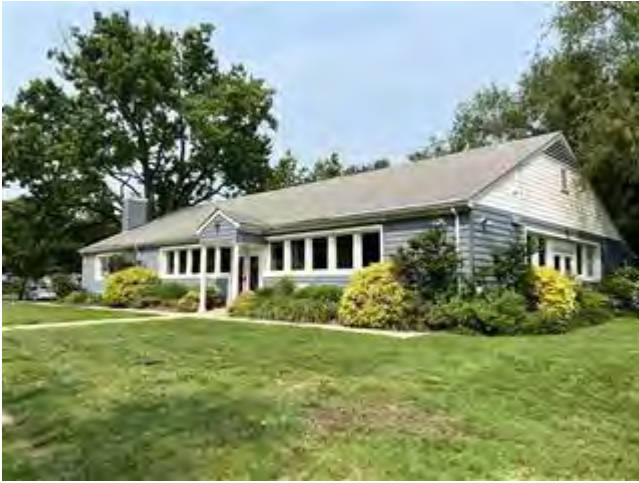
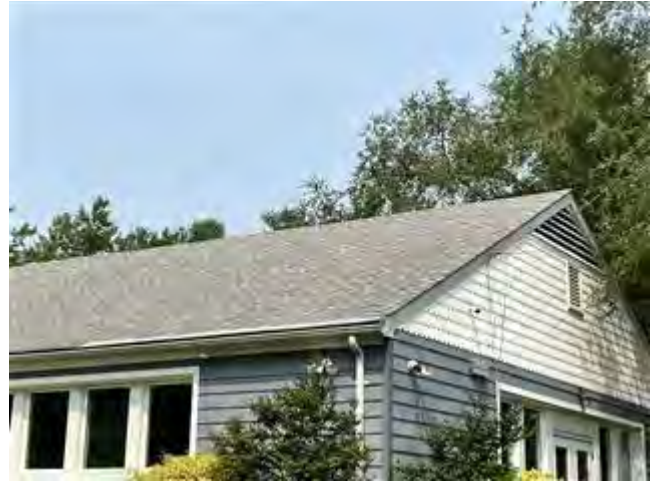
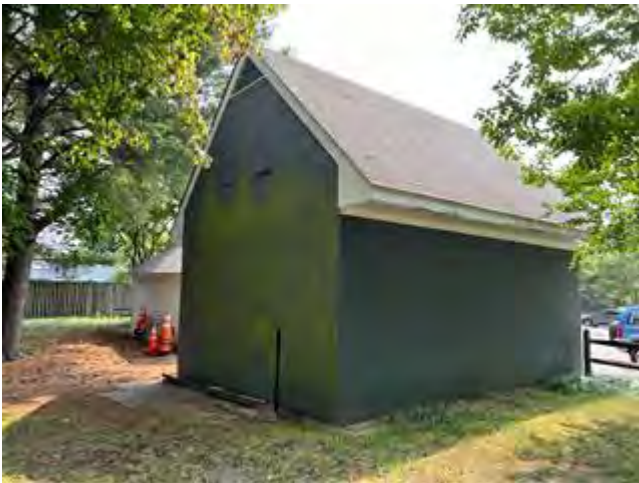
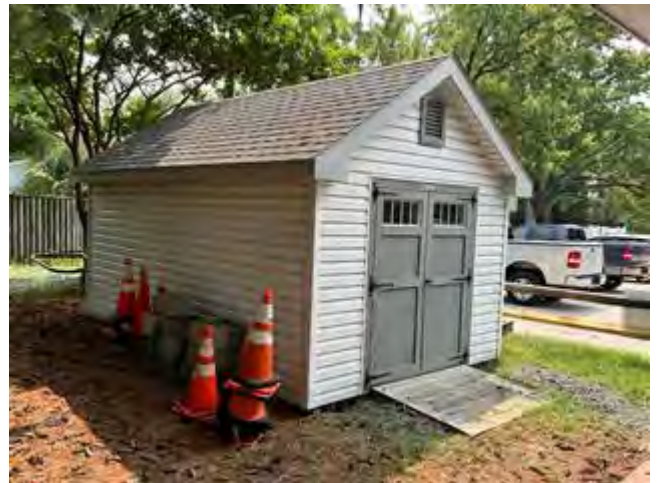
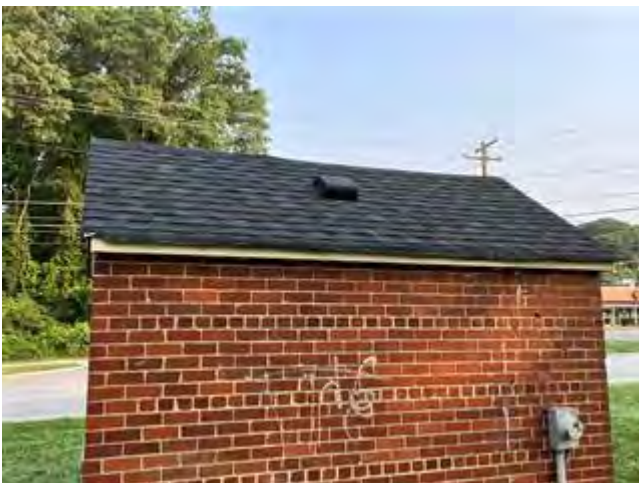
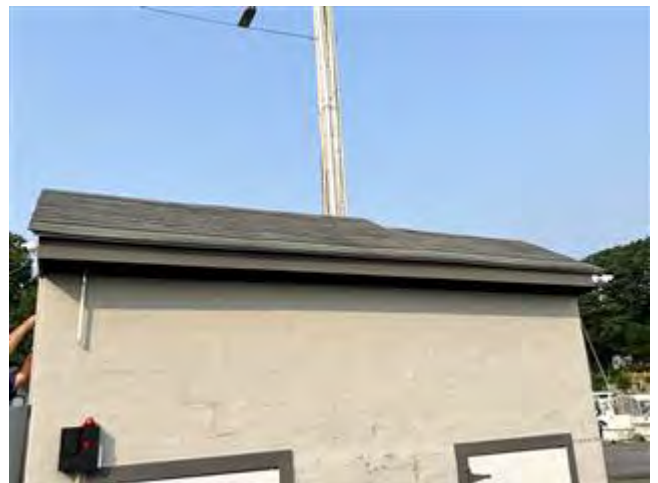
Building Roofing. The buildings have asphalt shingle roofs that appear in good condition. We noted some shingles curling.

Asphalt shingle roofs can have a useful life of 20 to 50 years, depending on the weight and quality of the shingle. Weathered, curled, and missing shingles indicate they may be nearing the end of their useful life.

Annual inspections are recommended, with cleaning, repair, and vegetation mitigation performed as needed. Access, inspection, and repair work should be performed by contractors and personnel who are experienced in the types of roofing used for the facility with the appropriate access equipment.

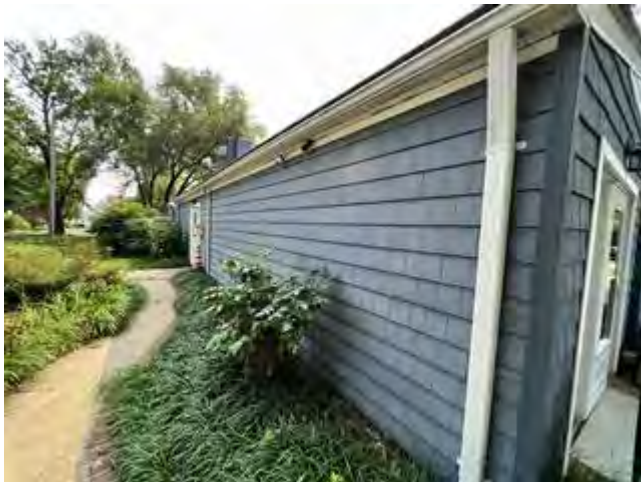
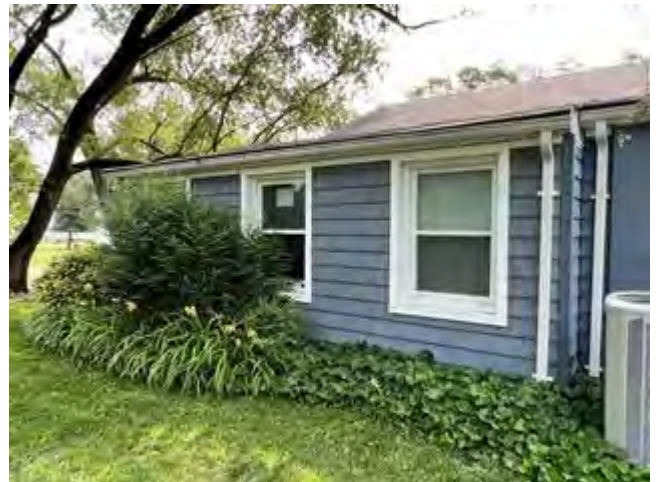
Gutters and Downspouts. The clubhouse has aluminum gutters and downspouts. The gutters and downspouts appear to be in good condition.

It is recommended that all gutters be cleaned at least twice each year. If many trees are located close to a building, consider installing a gutter debris shield to let water into the gutters but filter out leaves, twigs, and other debris.

It is recommended that gutters and downspouts be installed on all buildings. It is also recommended that the discharge from the downspouts be extended at least ten feet away from the foundations.

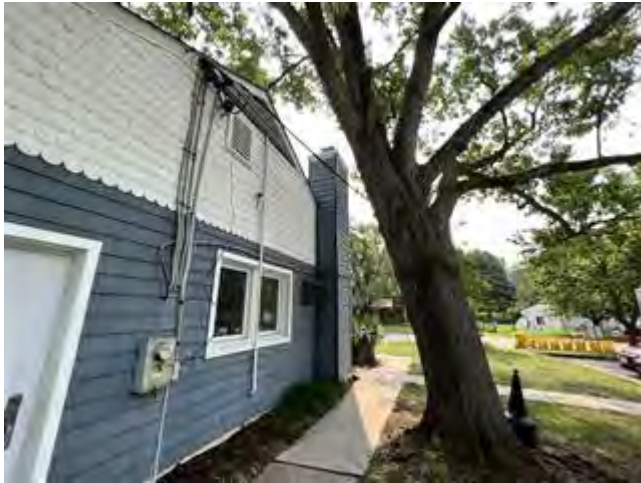
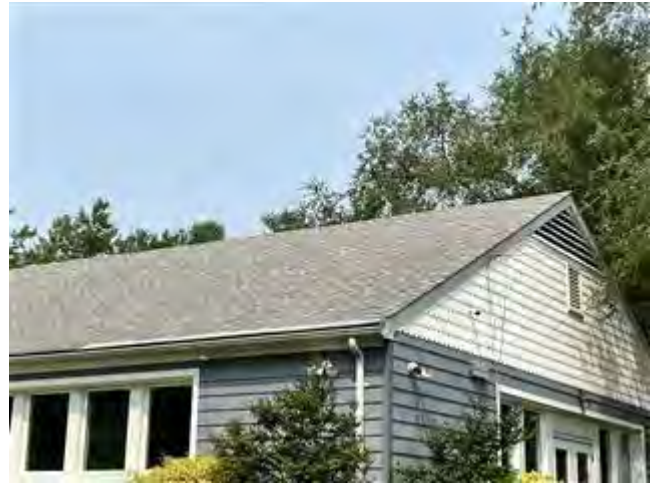
Siding and Trim. The exterior of the clubhouse building is clad in vinyl or PVC siding and trim. The siding and trim materials generally appear in good condition. Replace damaged siding sections as discovered and replace caulk when it cracks or separates from the substrates.

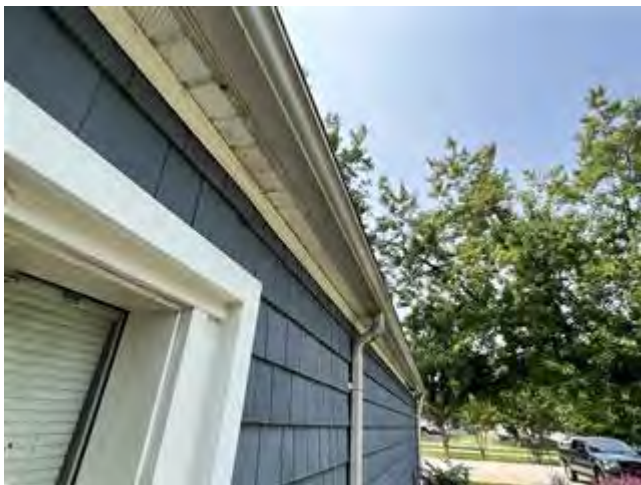
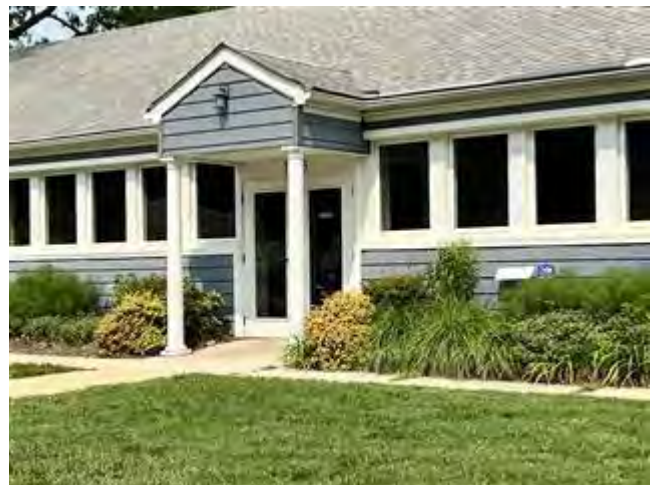
Vinyl Soffit. The Association maintains vinyl clubhouse roof eave soffits. The vinyl soffits appear to be in good condition.

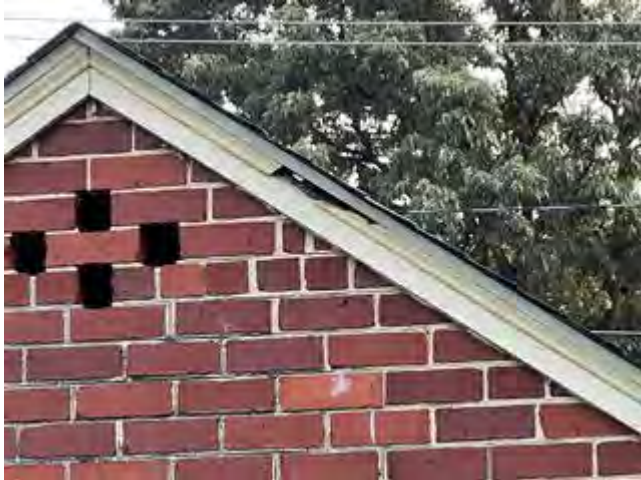
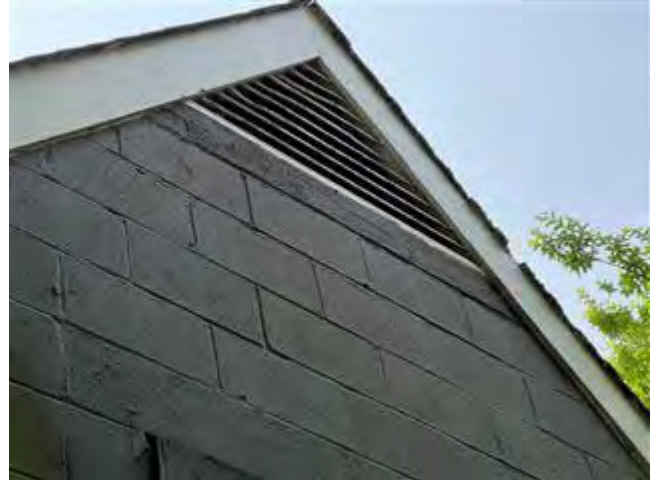
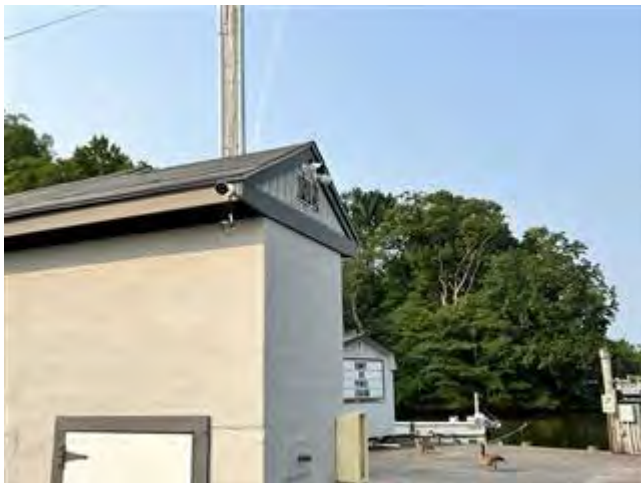
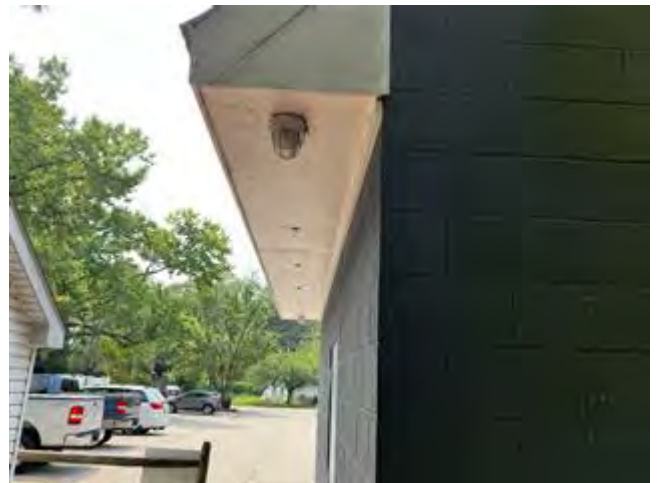
Wood Materials. Wooden exterior materials are typically repaired as needed during normal painting cycles. Painting cycles for wooden exteriors vary between five and ten years depending on the wood grade, the materials' quality, and the finished work. We have programmed the funds to replace deteriorated and damaged sections of wood trim as they were discovered during the painting and caulking activities. The Association gatehouse has rotted sections of wood trim at the fascia. The wood gable vents need to be maintained and painted.

The Association maintains the exterior wood trim incorporated into the garage, gatehouse, and pumphouses. The Association may consider replacing failed trim sections with composite or capped PVC materials.

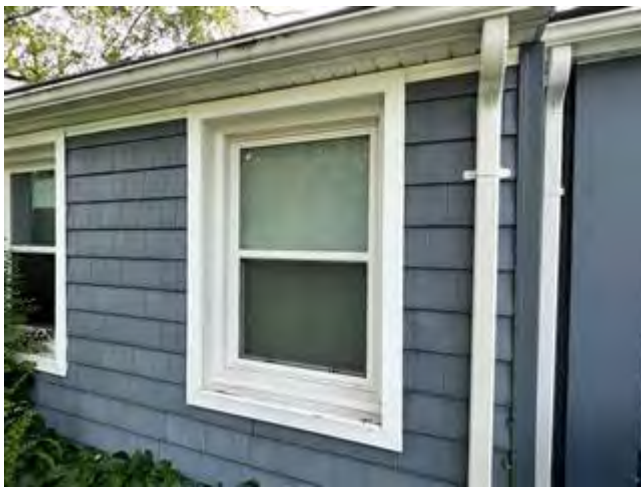
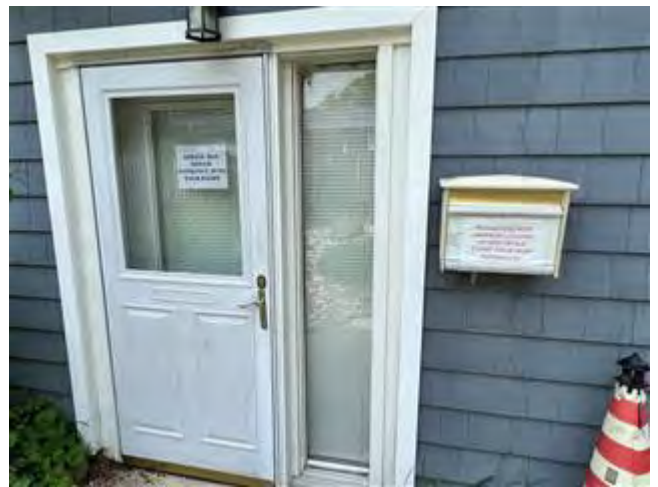
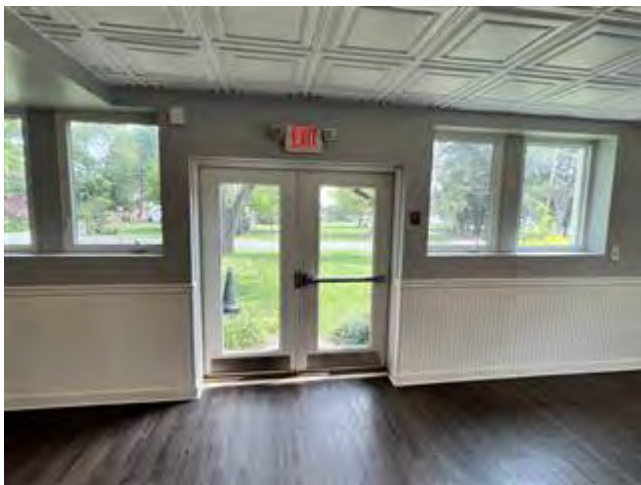
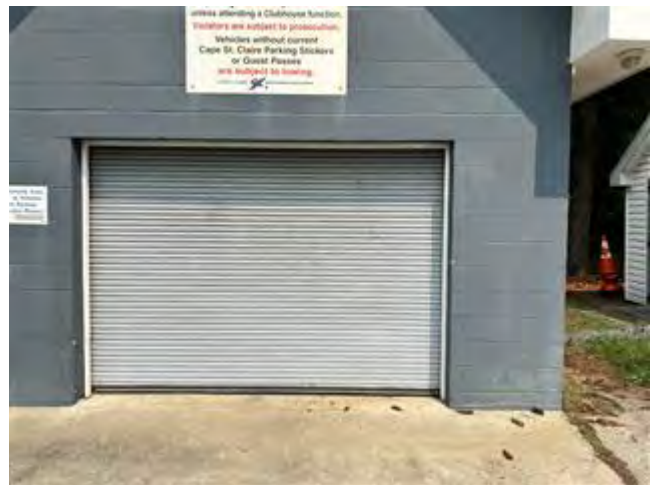
The windows and doors appear to be generally in good condition.

In general, we recommend coordinating the replacement of these units with other exterior work, such as siding and roof replacements. The weather tightness of the building envelope often requires transitional flashing and caulking that should be performed in coordination. Warranties and advantages in 'economy of scale' can often result in lower overall replacement costs and more reliable results. Lastly, coordinated replacements offer the opportunity to correct initial construction defects and improve the effectiveness of details with improved construction techniques and materials.
