LEVEL 1 REPLACEMENT RESERVE REPORT FY 2024 CAPE ST. CLAIRE IMPROVEMENT ASSOCIATION

CAPE ST. CLAIRE IMPROVEMENT ASSOCIATION

millerdodson
Capital Reserve Consultants

LEVEL 1 REPLACEMENT RESERVE REPORT FY 2024
CAPE ST. CLAIRE IMPROVEMENT ASSOCIATION

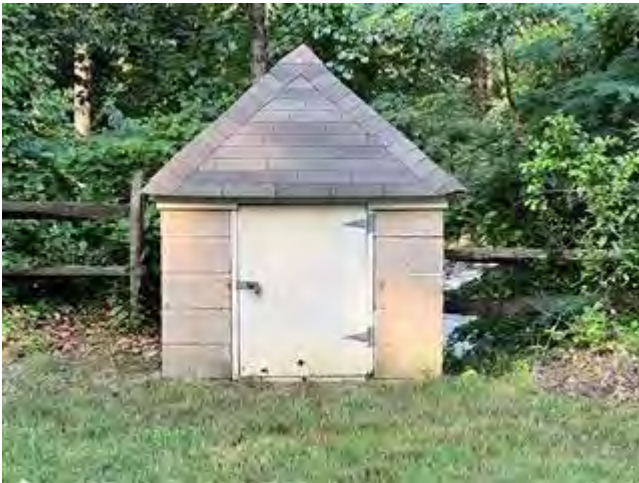
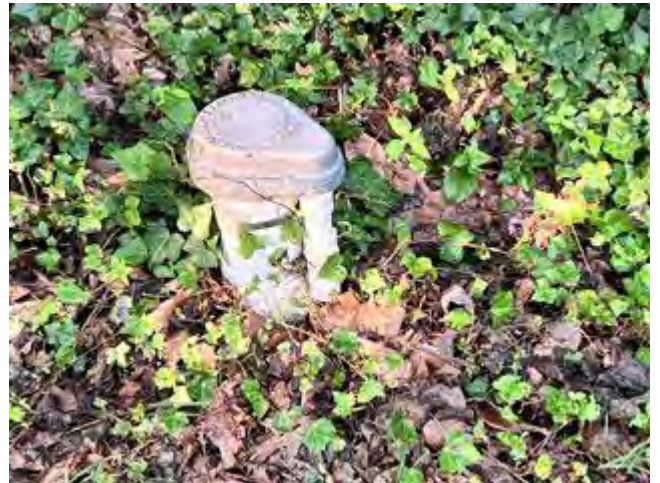
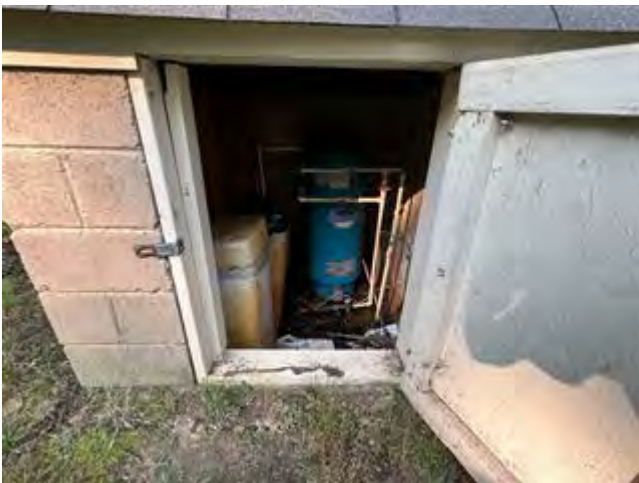
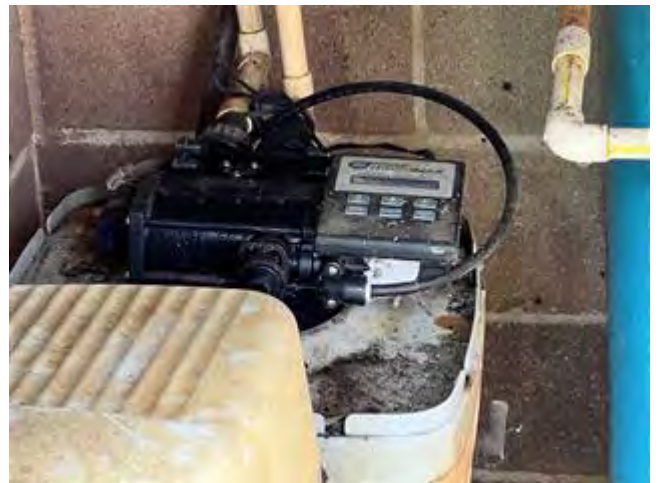
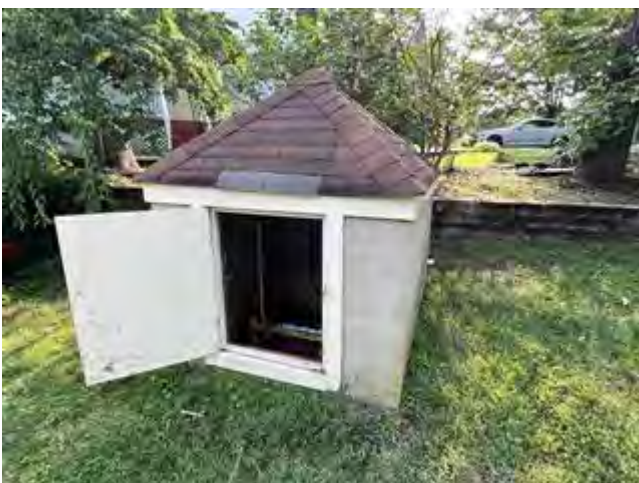
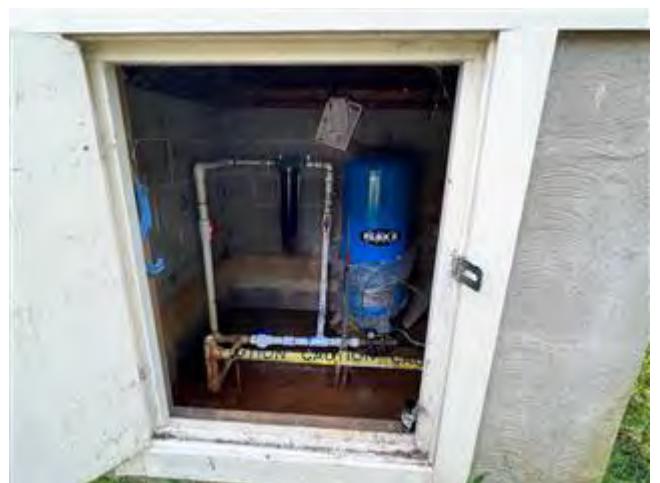
Pumphouses and Wells. The Association maintains two pumphouses with wells located at Deep Creek and Lake Claire, which appear to be in good condition and serve wells, submersible jet pumps, pressure tanks, and at Deep Creek, a water softener, which are all reportedly in good operating condition. The pumphouses are concrete block construction with asphalt shingle roofs and wood entrance doors. The pumphouse at Lake Claire has cement parging on the exterior of the concrete block structure.

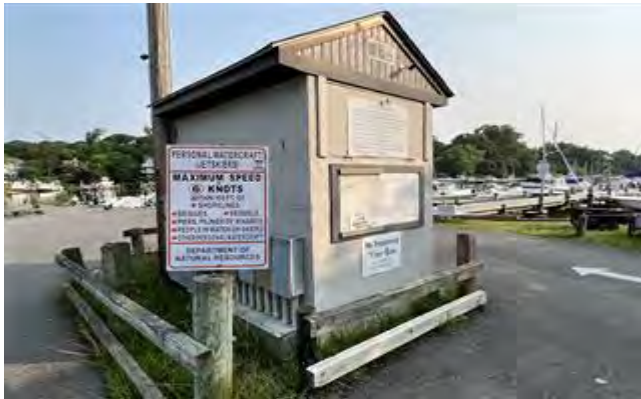
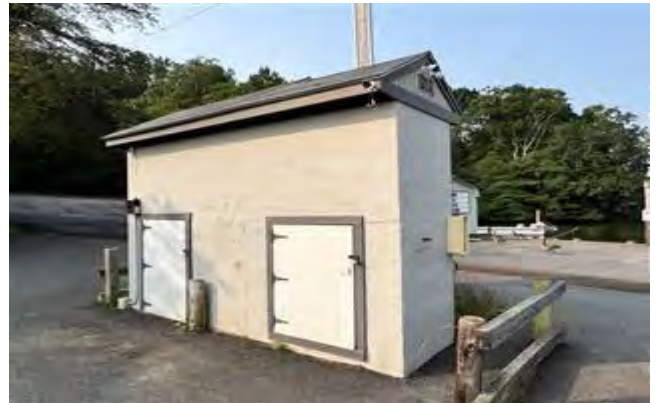
Compressor Building. The Association maintains a utility building at Deep Creek that houses an air compressor, electrical service, panels, security cameras, and a recorder. The building is constructed of cement block with an asphalt shingle roof and wood siding, trim, and doors that appear to be in fair condition.

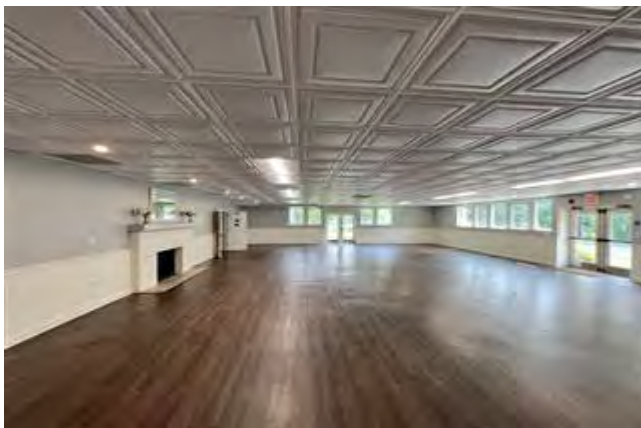
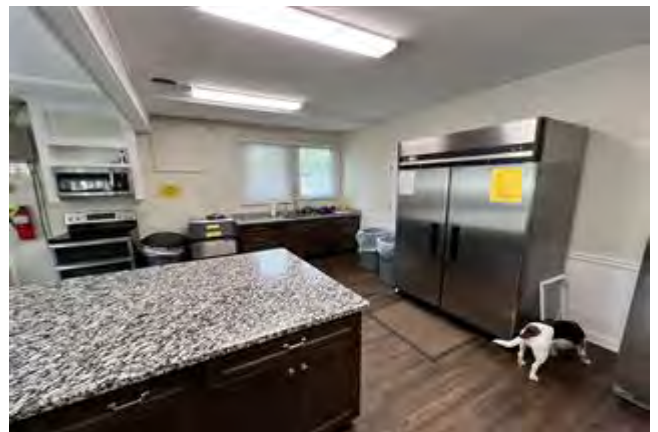
Common Interiors. The Association maintains the Clubhouse interiors, including the main hall, lobby, kitchen, offices, restrooms, corridors, and other common interior spaces, all of which appear to be in excellent condition.

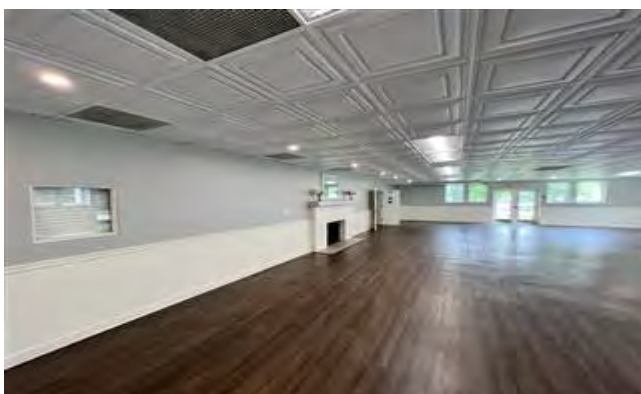
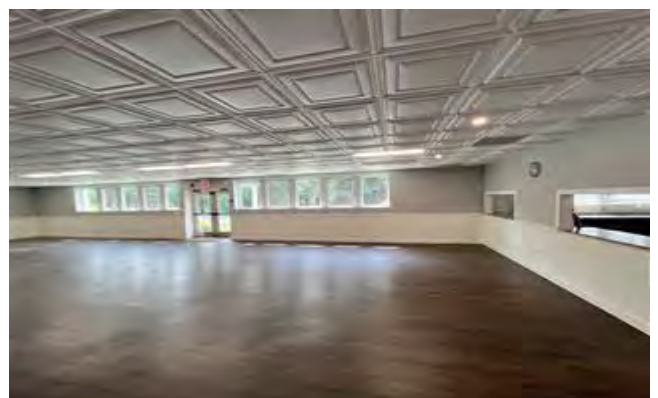
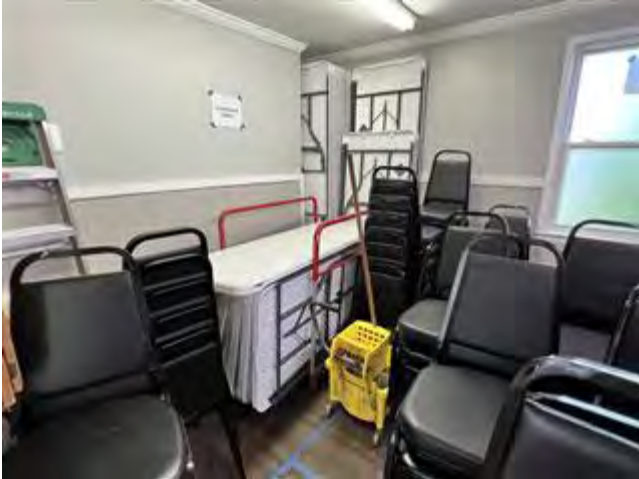
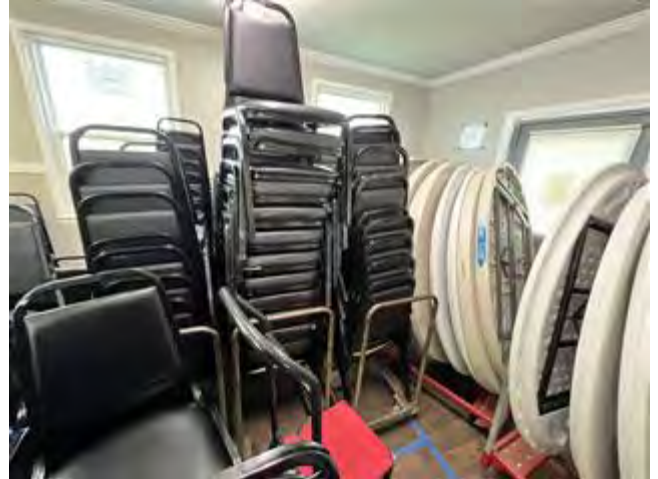
Main Hall. We have included the following items in the analysis: furnishings, laminate wood flooring, ceiling tile, light fixtures, and exit lights, which all appear in excellent condition.

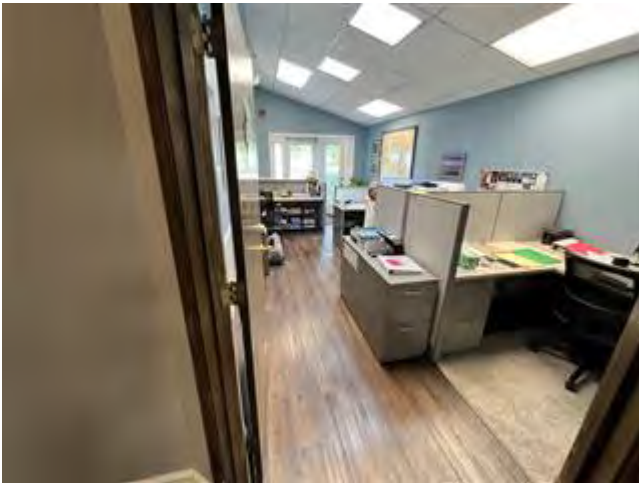
Offices. The Association maintains the offices. We have included the following items in the analysis: furnishings, office equipment, carpet, and light fixtures, which all appear to be in excellent condition.

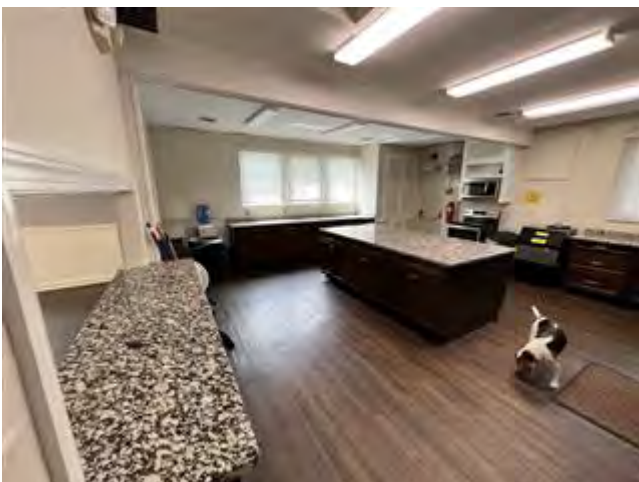
Kitchen. We have included the following items in the analysis: furnishings, appliances, sink and faucet, base and wall cabinets, solid surface countertops, exit lights, and laminate or engineered wood flooring, which all appear in excellent condition.

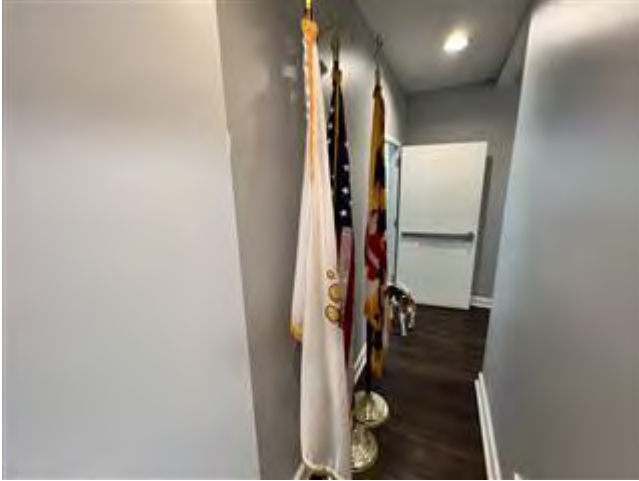
Corridors. We have included the following items in the analysis: laminate wood flooring, lighting fixtures, and emergency and exit lights, which all appear to be in excellent condition.

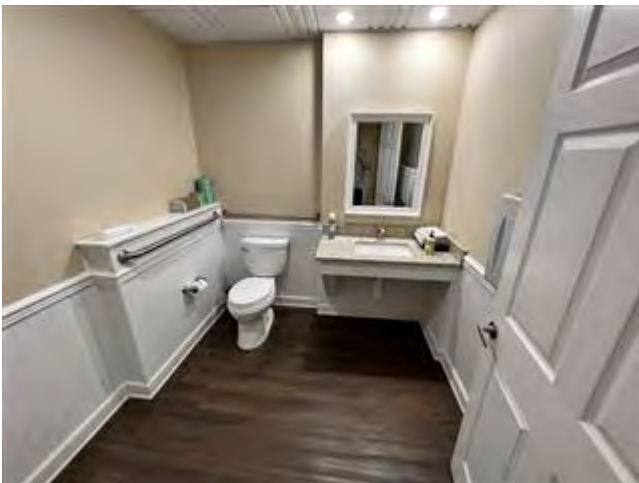
Restrooms. We have included the following items in the analysis: fixtures, laminate wood flooring, mirrors, lighting fixtures, and exit lights, which all appear to be in excellent condition.

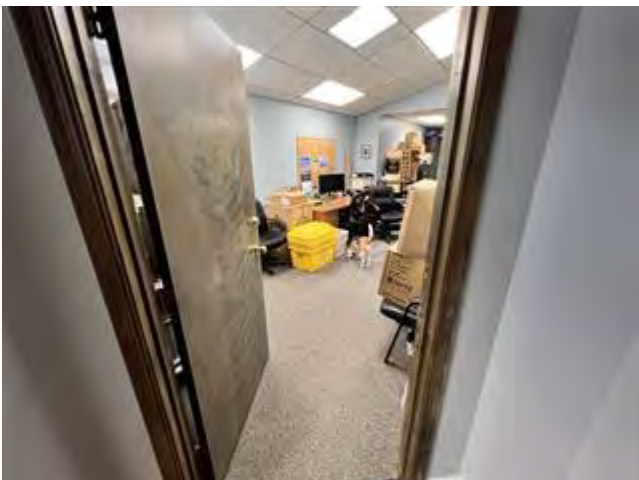
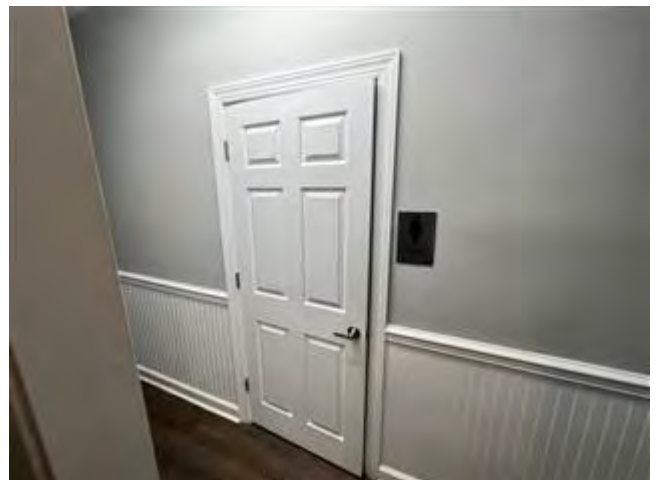
Interior Doors. The doors and frames are currently in good condition. Recommended maintenance includes inspecting all six sides of the door at least once a year and recoating the doors every five years or as needed to keep these doors in good shape for the lifetime of a building. We have not included interior doors in this study.

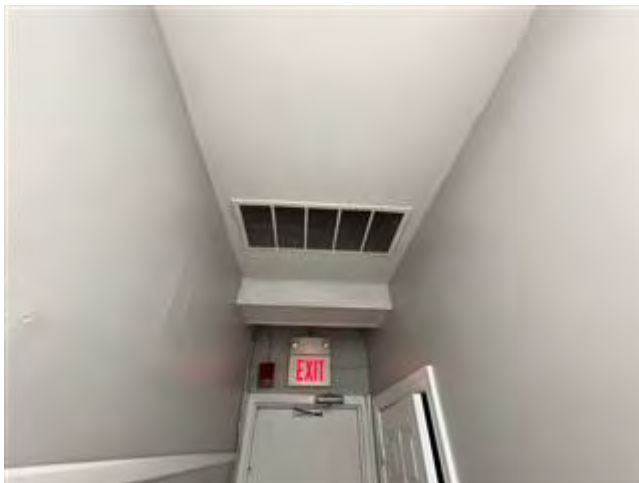
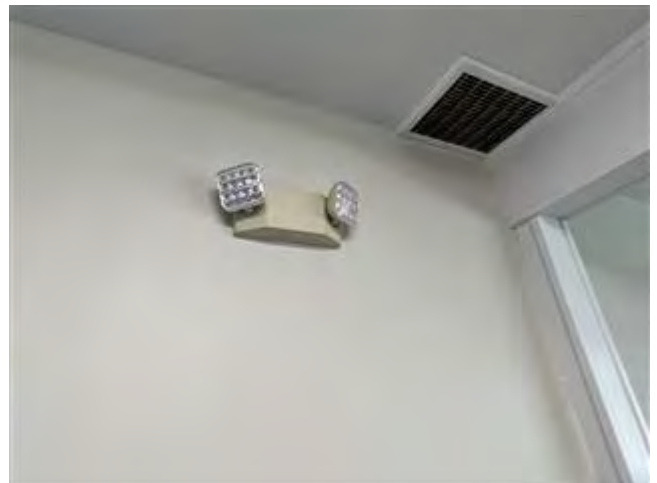
Exit Lights. The building uses illuminated exit lights at each of the exits. The exit lights appear to use LED light sources. The general condition of the building's exit lights appears good.

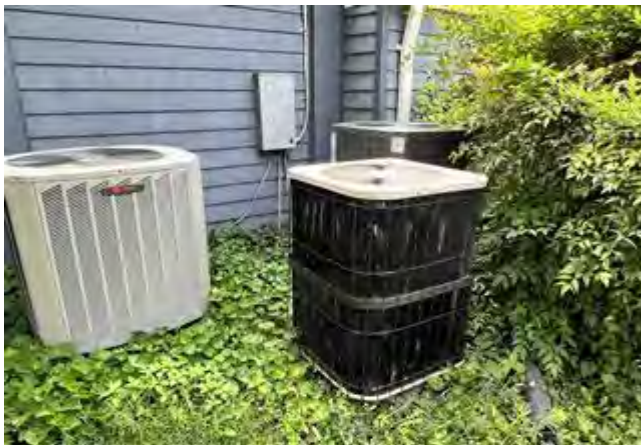
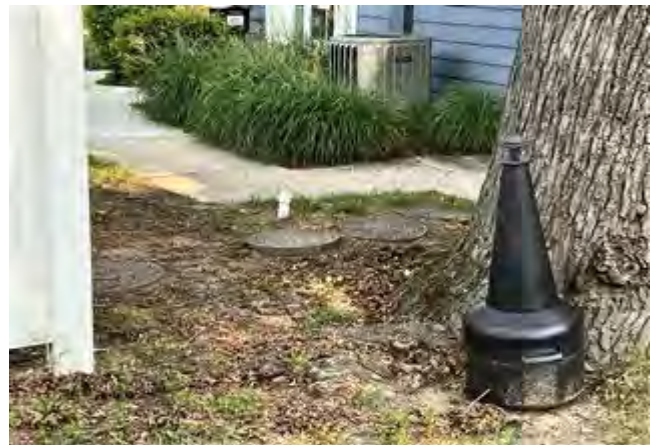
Split and Package HVAC Systems. The facility's heating, ventilation, and air conditioning (HVAC) systems are reported to be in good operating condition. Detailed inspection and testing of these systems are beyond the scope of this study.

Even though manufacturers continue to predict 15 to 20-year life cycles for HVAC equipment that use these new refrigerants, historical data does not prove this. We, therefore, recommend anticipating a normal economic life of 15 years for all HVAC equipment that uses pressurized refrigerants of these types.

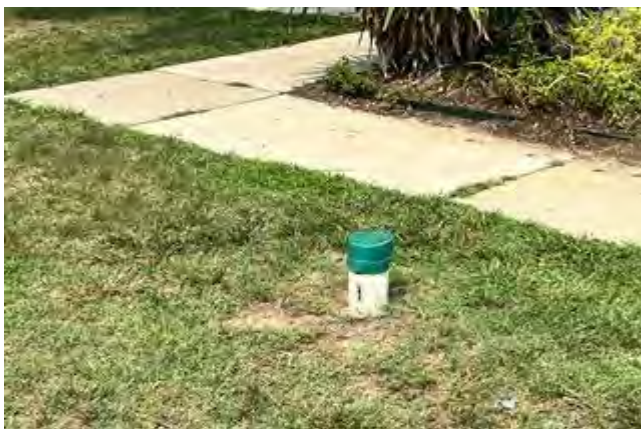
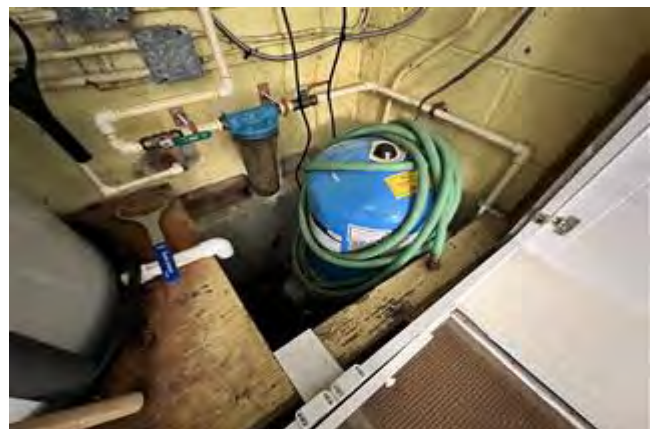
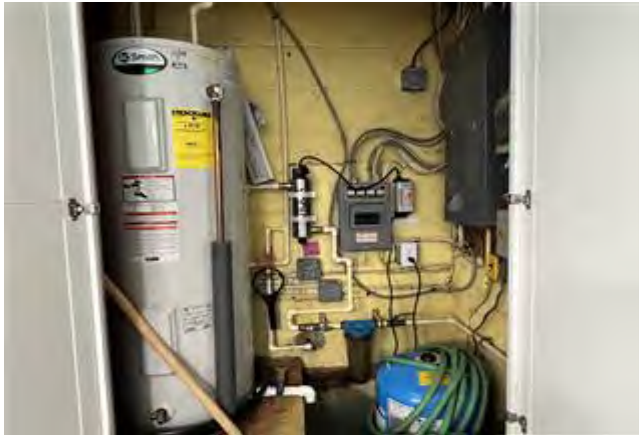
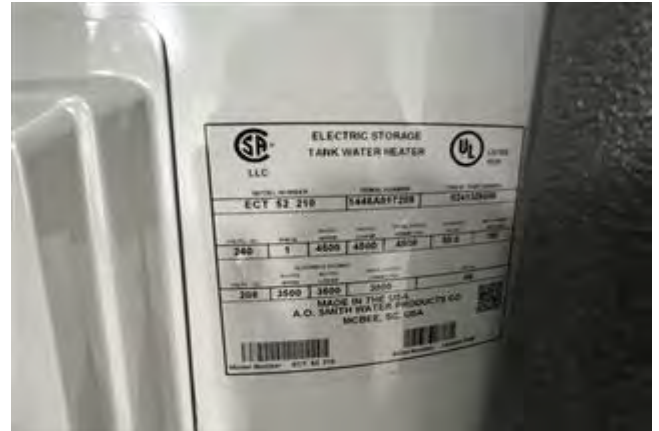
Building Piping. CPVC supply piping is presumed to be used in the clubhouse building's main service piping. A well, pump, and pressure tank serve the building. These lines should be replaced as needed, and we included an allowance in this study. We also included the water heater in the study, which appears to be in good condition.

To better understand the condition of this facility's pipes and water supply lines, we recommend performing an expert evaluation of the piping. This evaluation should estimate the piping systems' remaining useful life, the water supply's condition, and recommendations for replacement to maximize the remaining useful life of this facility's piping systems.

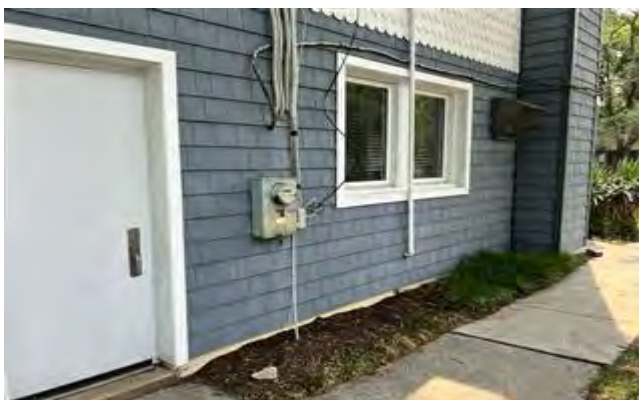
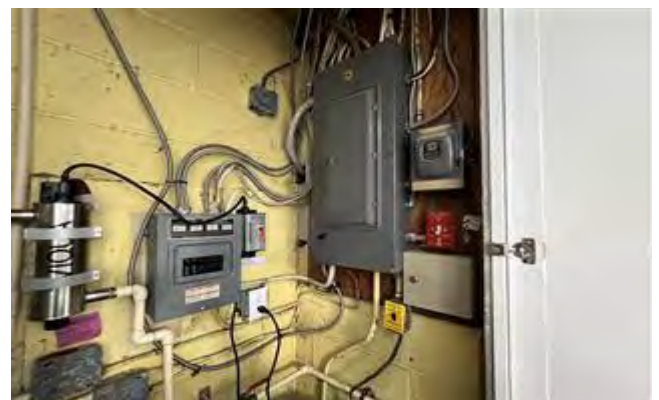
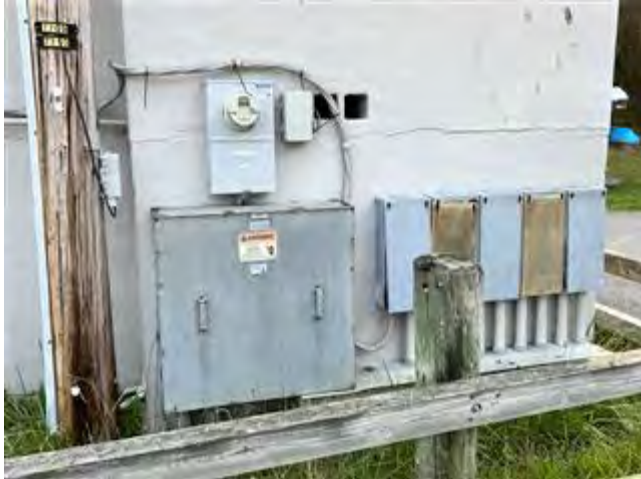
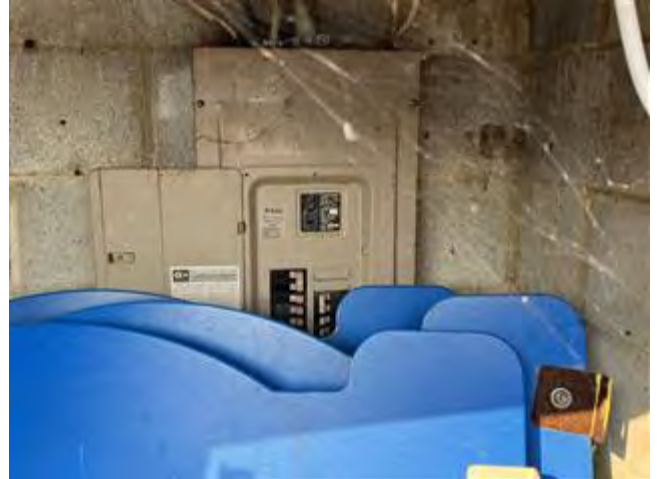
Building Primary Electrical Service and Switchgear. The building's primary electrical service and switchgear include the facility's incoming service equipment, meters, transformers, and distribution equipment panelboards, disconnects, relays, fuses, and circuit breakers. Electrical switchgear has a rated service life of 50 years or more. The electrical systems of the building are reported to be operating normally, and the overall condition of the switchgear appears to be good. We have included funding in the Reserve Analysis for distribution panel replacement.

The primary electrical service and switchgear date to the original construction of the building, and we understand that replacement parts are still available for the equipment. As the switchgear continues to age, obtaining replacement parts can be expected to become more difficult. When parts are no longer available or when the condition of the switchgear deteriorates sufficiently, the Association will have to replace or upgrade the existing equipment.

Electrical switchgear requires ongoing maintenance for proper operation and reliability. To maintain this equipment properly, periodic tightening of all connections is recommended every three to five years. Insurance policies may sometimes have specific requirements regarding tightening electrical connections.

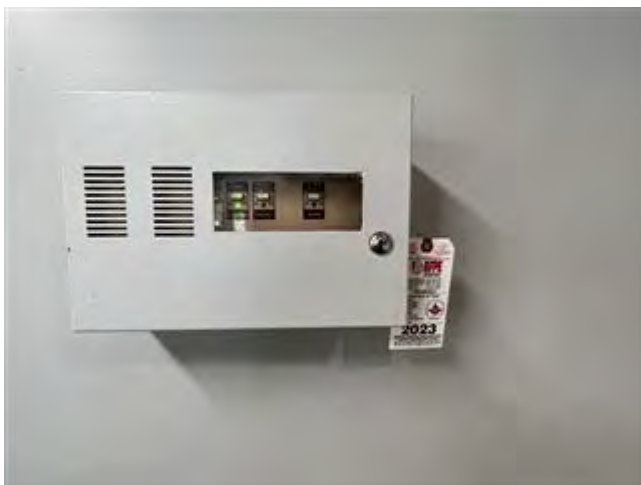
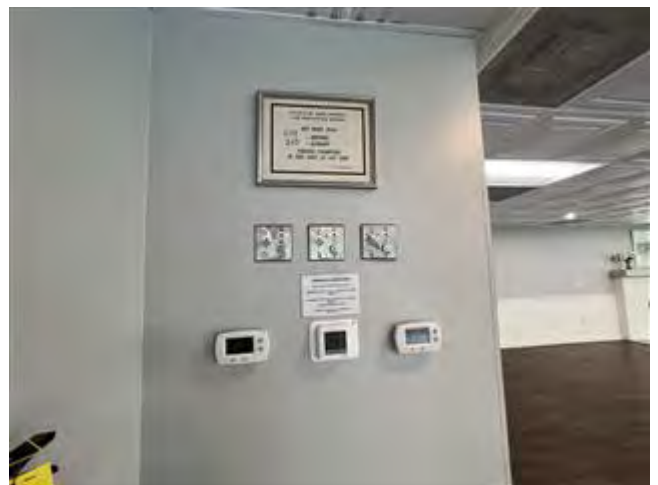
Fire Safety Systems. The building has a fire safety system with a fire alarm control panel, duct detectors, pull stations, and alarms, which are reported to operate normally. Testing and inspection of fire safety systems are not included in this study.

We recommend having your entire fire safety system inspected and evaluated by a professional in this field who is familiar with your area of the country. In addition, a comprehensive preventative maintenance program will ensure the maximum possible useful life from these components, and a qualified professional can help set up and implement such a program.

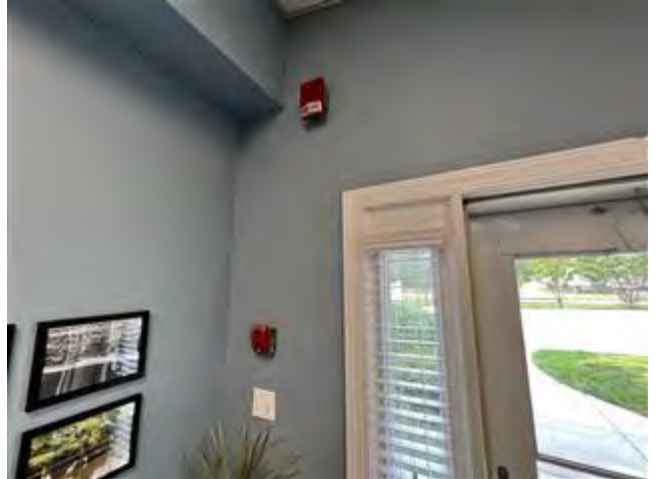
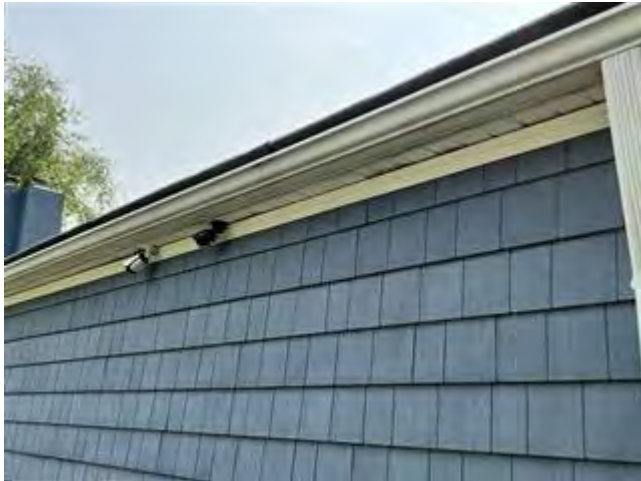
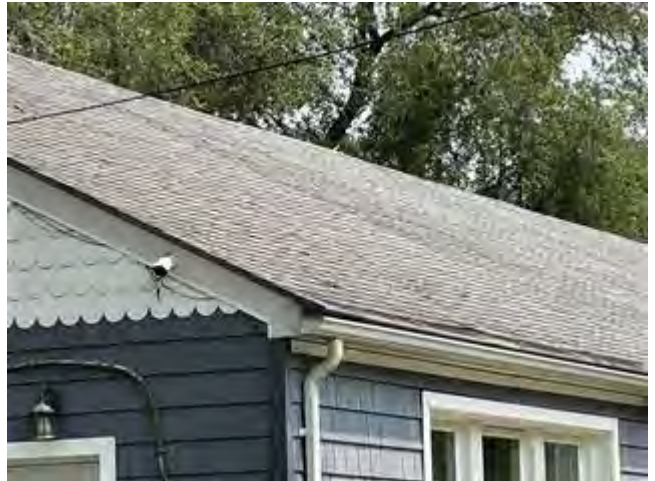
Security System. The Association maintains a security surveillance system to monitor access to the Clubhouse building. The building has a video-based security system with cameras installed at various locations in and around the building. The system records images on a hard drive. Electronic security represents a proactive approach to safeguarding occupants and property.

The service life for systems of this type is 15 years. While many of the system's components may function well beyond that point, the community will experience difficulty obtaining replacement parts and services for the system. Most manufacturers do not support hardware or software beyond this timeframe. We have provided an estimate of the approximate replacement cost based on our experience with other communities of similar size and our inspection of the visible components while on site.

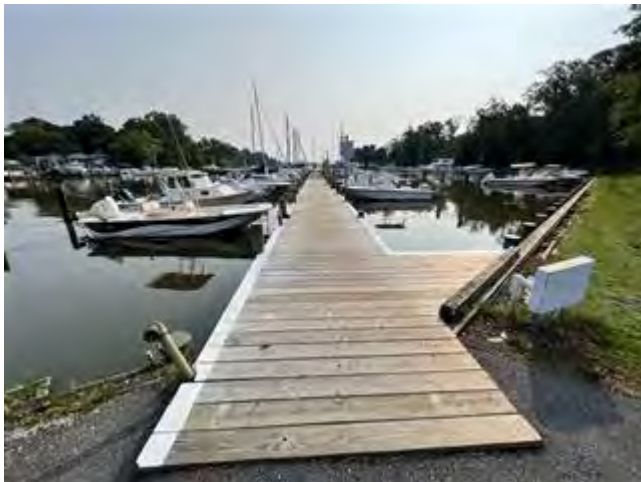
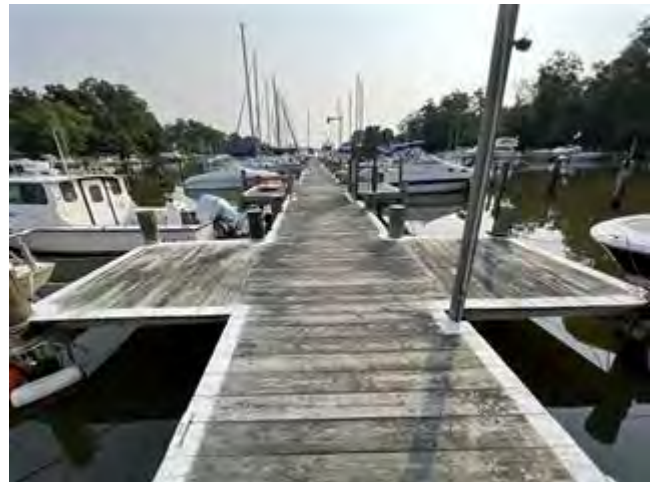
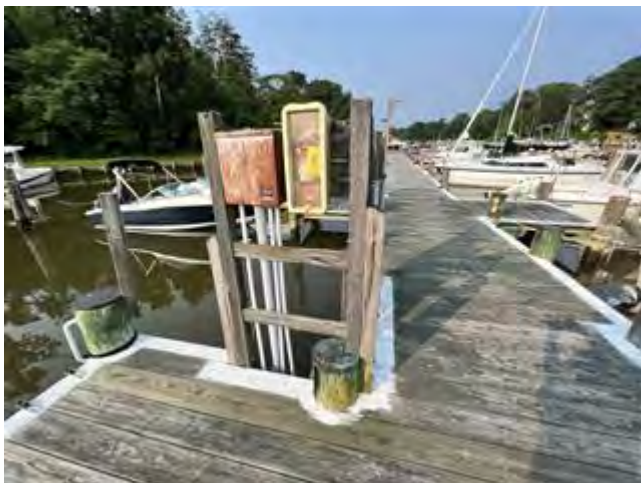
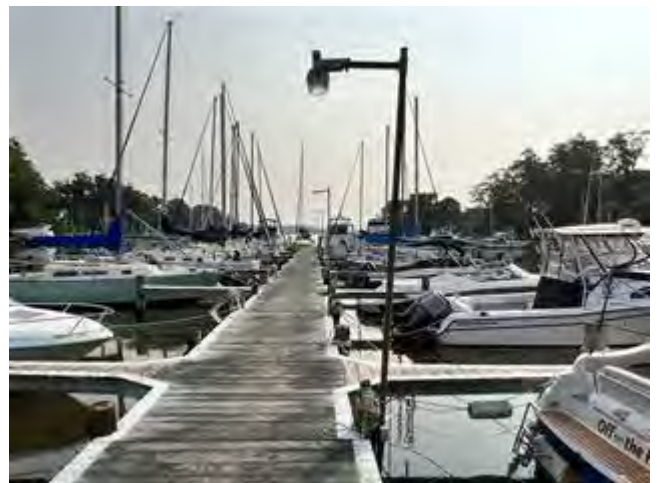
1. Deep Creek Pier. The Association is responsible for approximately 5,000 square feet of pressure-treated wood boat pier with 146 slips. The piers have electrical and domestic water service, a portable sewerage pump-out station, aluminum or wood ladders, ring buoys, and fire extinguishers. The piers also have security cameras and a recorder. The pier structures appear to be in overall fair condition with weathering and cracked decking.

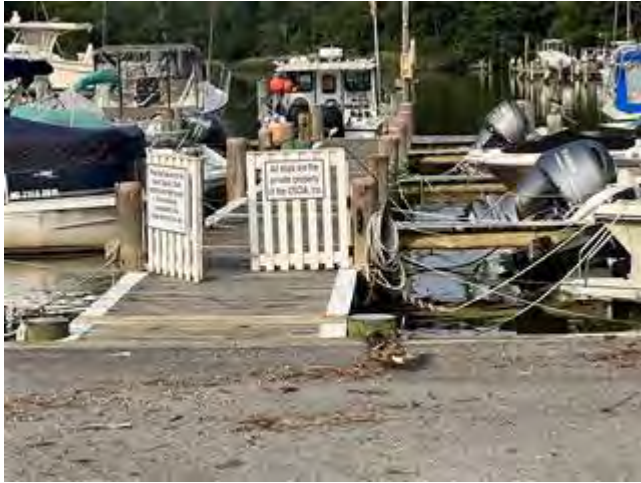
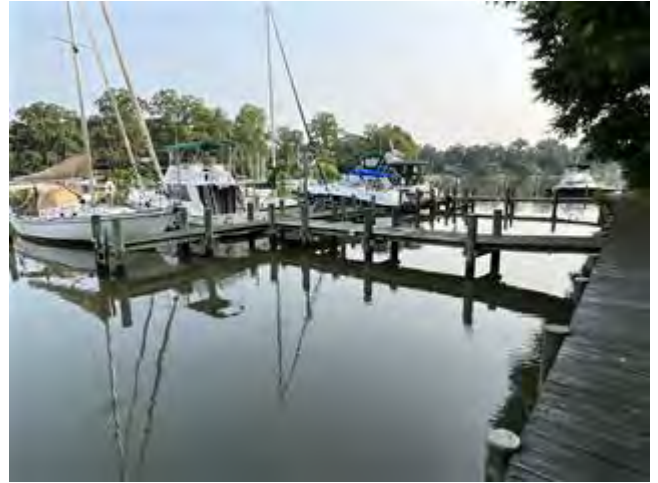
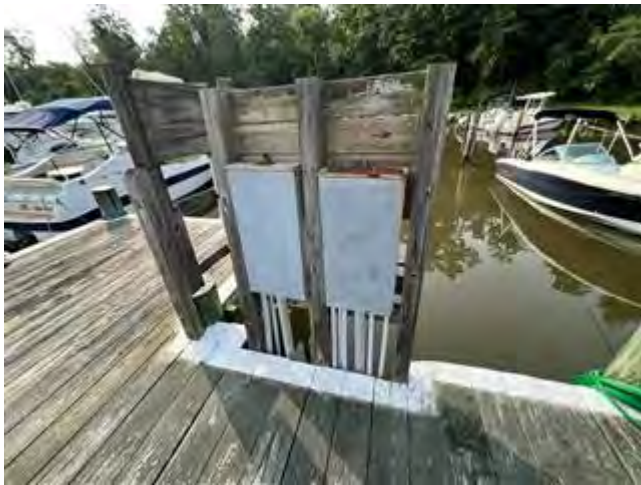
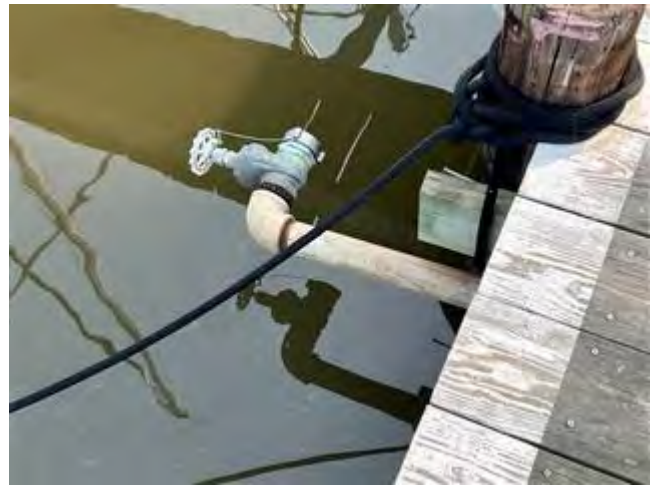
- The pier pilings appear to be in good condition.
- The freestanding (mooring) pilings appear to be in good condition.
- The pier structure with stringers appears to be in good condition.
- The main wood pier decking appears in fair condition, with weathered deck boards; some are cracked or split.
- The pier's electrical and plumbing systems appear to be in good condition, with weathering and corrosion of the electrical panels.

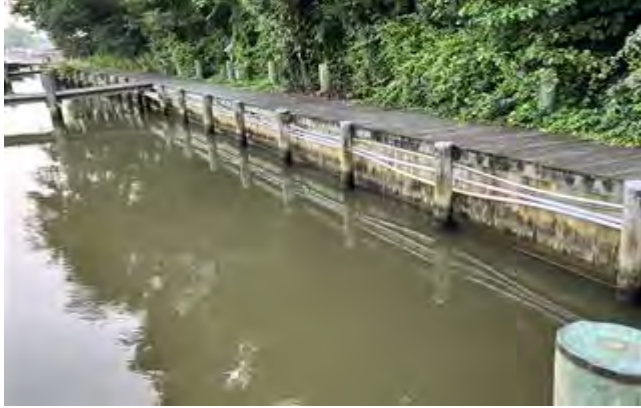
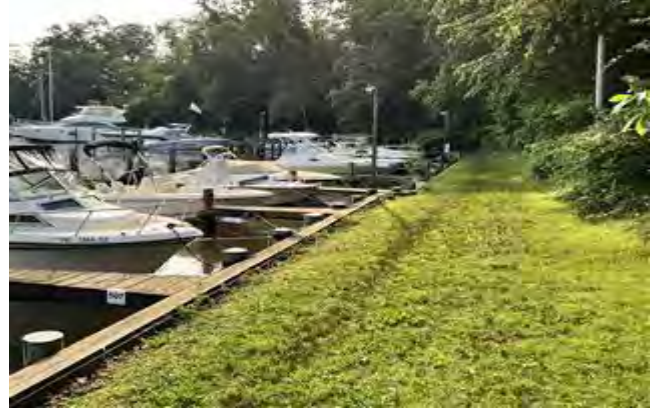
Shoreline Erosion Controls. The Association is responsible for approximately 800 linear feet of shoreline creosote-treated wooden bulkhead and 200 linear feet of armor stone revetment along the waterfront portion of the Deep Creek pier to help control erosion. Part of the bulkhead, stone revetment, and pier along the shoreline were recently replaced.

- **Bulkheads.** The newer bulkhead appears to be in good condition. No significant defects were noted. We noted no leaning sections, sinkholes behind the wall, or exposed anchor tie rods. We could not see below the waterline. The older section of the bulkhead appears to be in fair to marginal condition with discoloration.

Bulkheads have a rated service life of 50 years. We recommend that the Association start planning to replace the bulkhead due to its age while 85% of the bulkhead is intact and permits can be acquired. Bulkheads need to be designed by a qualified professional.

We recommend that the wood bulkhead be inspected at least once yearly and immediately following a storm that exposed the wall to significant wave action.

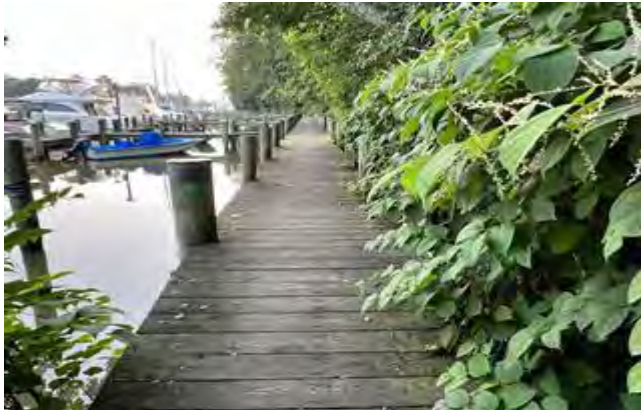
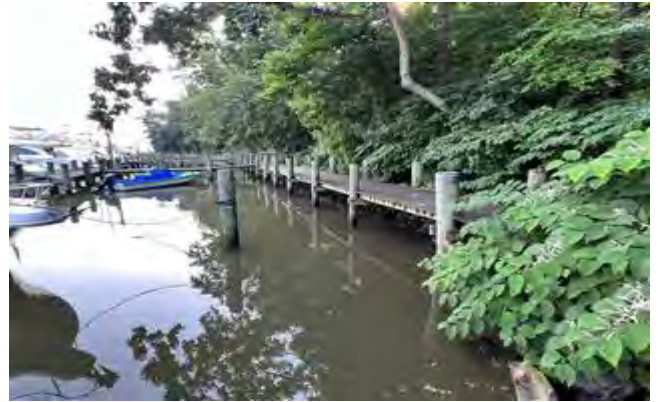
Paths and Walkways. The Deep Creek pier area also has a pier section between bulkhead sections with armor stone revetment that was recently replaced and appears in good condition. Along the bulkhead are wood walkways and a section of gravel path. The wood walkway appears in fair to marginal condition, and the gravel path appears in good condition and does not extend the whole way along the bulkhead from the Deep Creek pier access road.

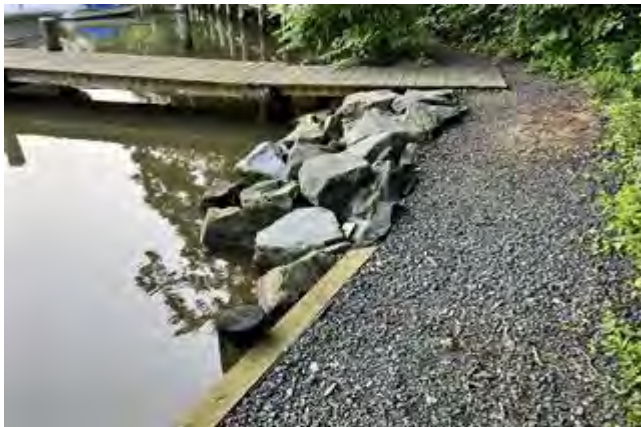
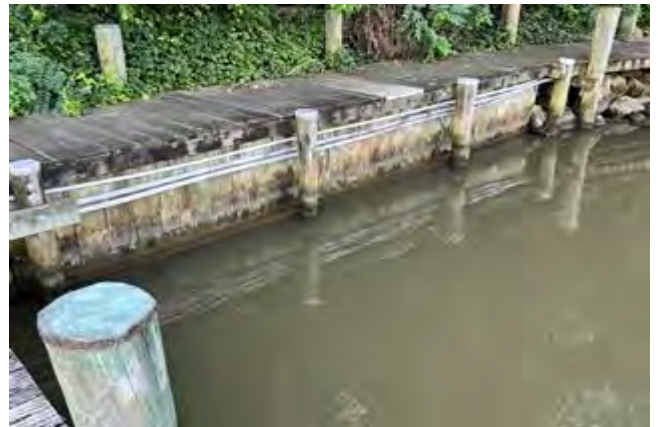
- **Shoreline Rip-Rap Revetments.** The Pier Committee manages and maintains the shoreline permeable stone revetments installed in the Deep Creek pier area. Part of the revetment and a new section of the pier was recently replaced.

The newer revetment appears to be in good condition with no noted erosion or gaps but noted gaps in the older revetment where it meets the bulkhead. Permeable armor stone revetments, if properly maintained, can have a useful life of 30-50 years.

Keeping up with a rip-rap rock revetment's annual maintenance will help it to last a lifetime. Rip-rap rocks are designed to be durable and long-lasting. With proper upkeep, the rip-rap revetment has a lifespan of decades.

Because it is highly unlikely that all of the stone revetment components will fail and require replacement in the study period, we have programmed funds to replace 33% of these inventories to spread the funds over an extended timeframe to reflect the incremental nature of this work.

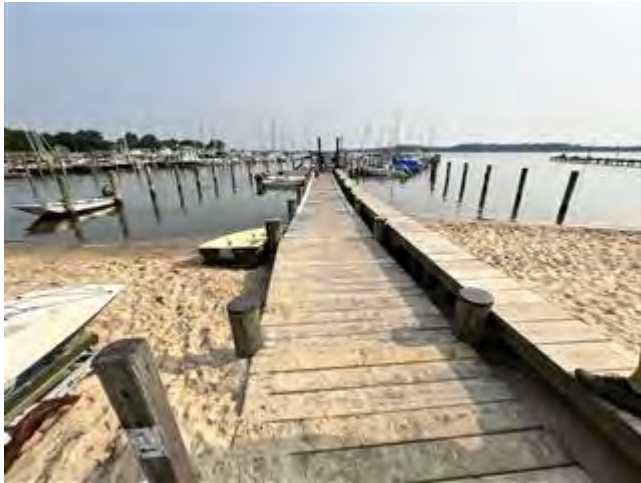
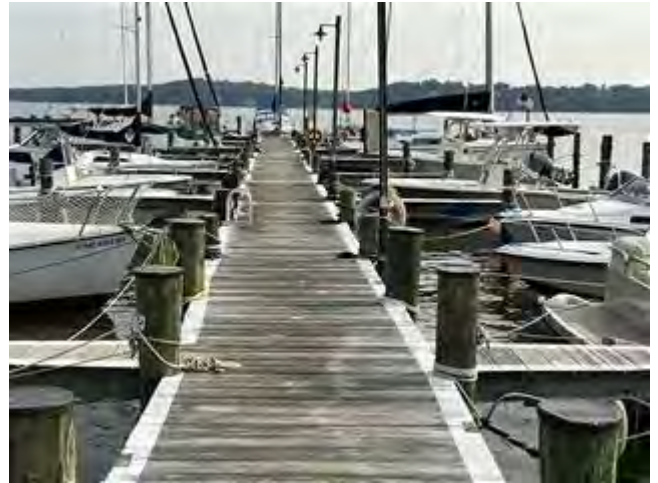
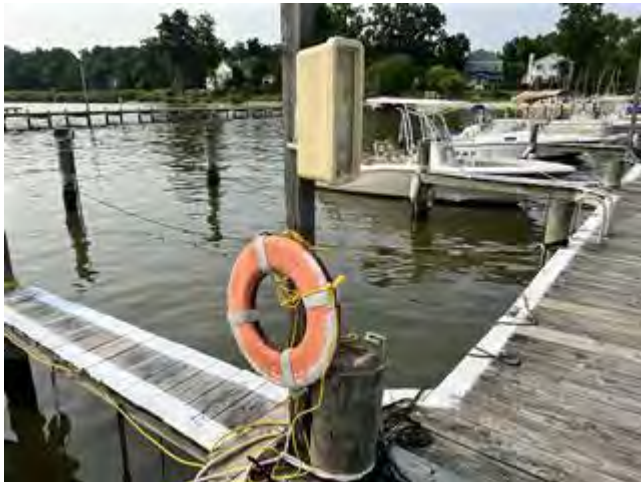
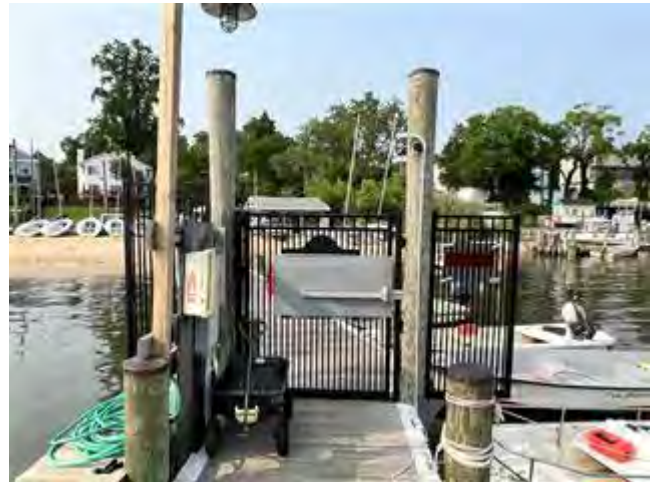
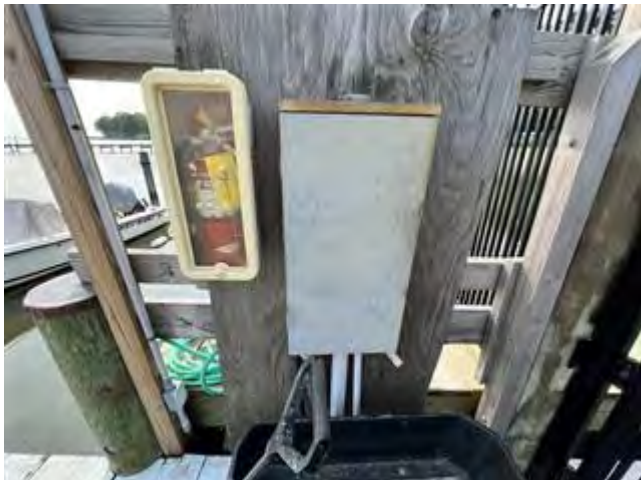
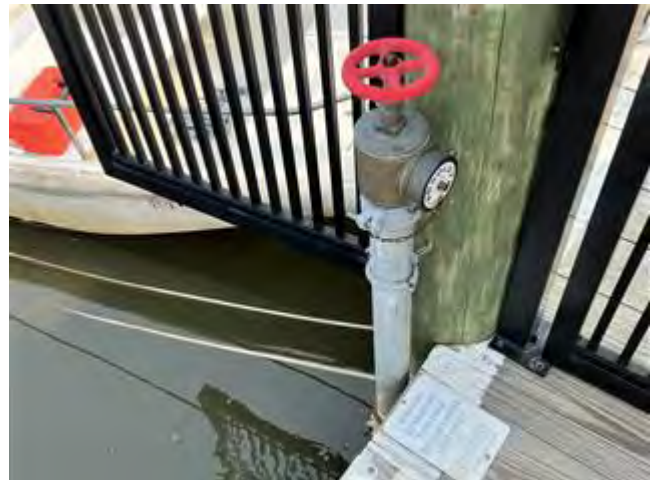
2. Lake Claire Boat Pier. The Association is responsible for approximately 3,712 square feet of pressure-treated wood boat pier with 69 boat slips at Lake Claire. The pier has a main stem, branches, and finger piers. The pier also has electrical service, light fixtures, water service, aluminum ladders, ring buoys, fire extinguishers, security cameras, a recorder, and a locked metal gate. The pier appears to be in overall good condition.

- The pier pilings appear to be in good condition.
- The freestanding (mooring) pilings appear to be in good condition.
- The pier structure appears to be in good condition.
- The main wood pier decking appears in fair condition, with weathered deck boards; some are cracked or split.
- The pier's electrical and plumbing systems appear to be in good condition, with weathering and corrosion of the electrical panels.

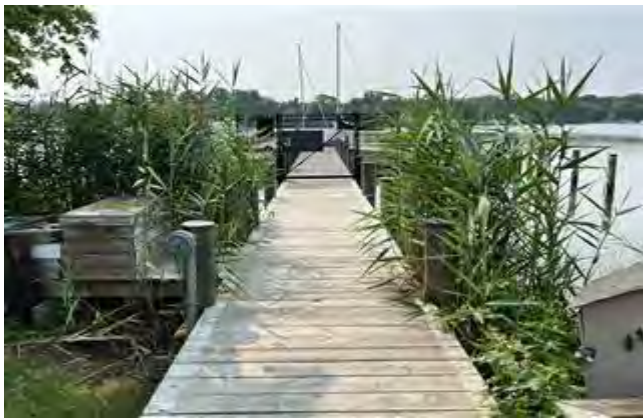
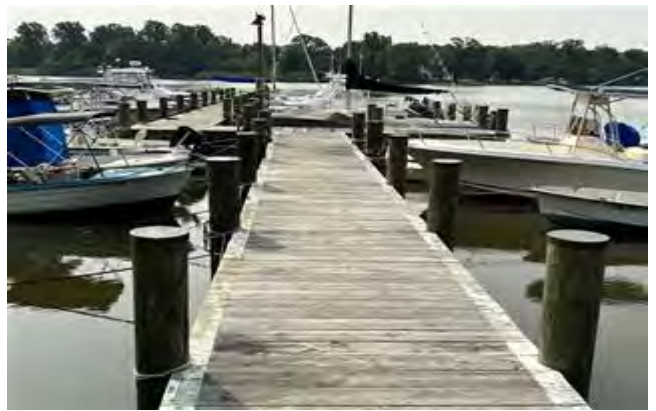
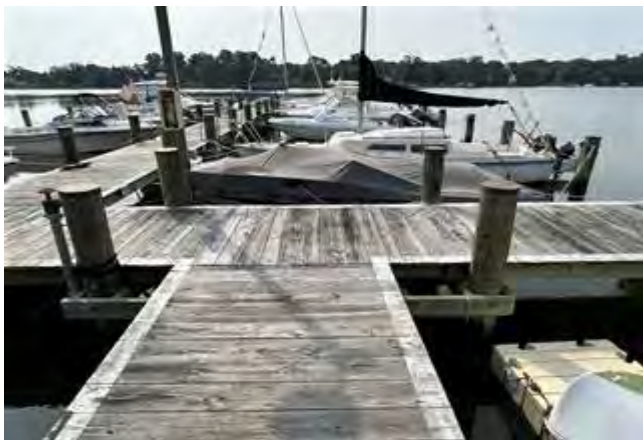
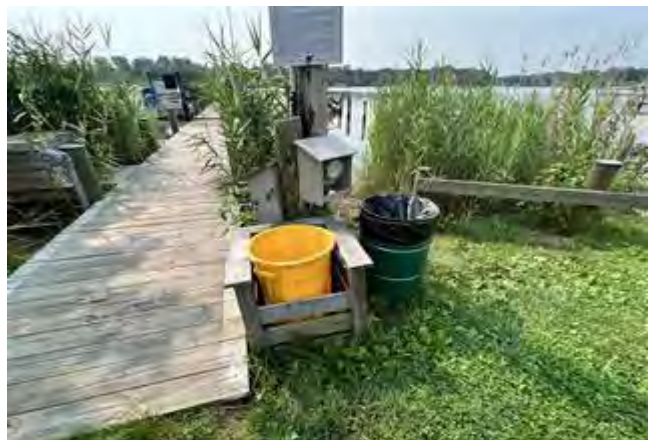
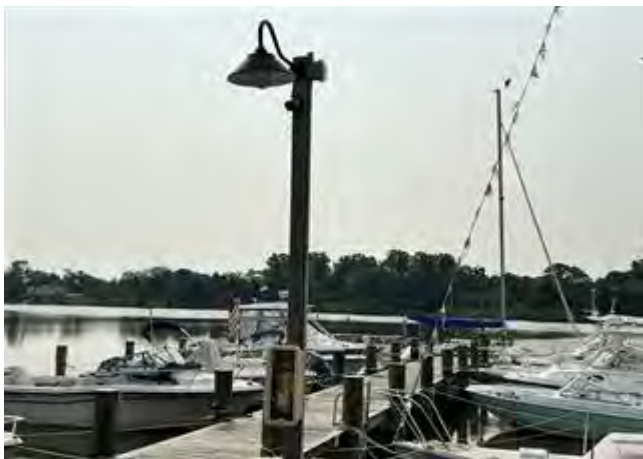
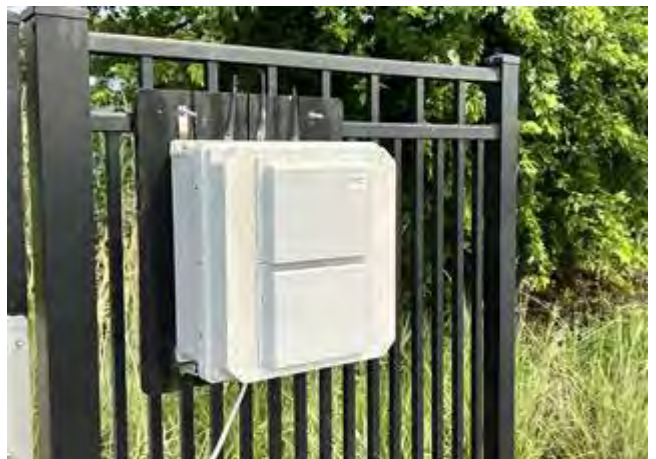
3. Little Magothy Pier. The Association is responsible for approximately 1,300 square feet of pressure-treated wood boat pier with 29 boat slips at the end of Skyway Drive. The pier has a main stem and branches. The pier also has electrical service, light fixtures, water service, aluminum ladders, ring buoys, fire extinguishers, security cameras, a recorder, and a locked metal gate. The pier appears to be in overall good condition.

- The pier pilings appear to be in good condition.
- The freestanding (mooring) pilings appear in good condition.
- The pier structures appear to be in good condition.
- The main wood pier decking appears to be in fair condition, with weathering.
- The pier's electrical and plumbing systems appear in good condition, with weathered deck boards; some are cracked or split.

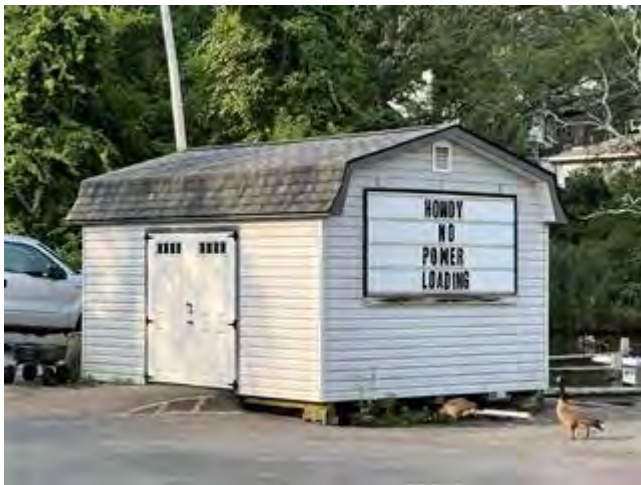
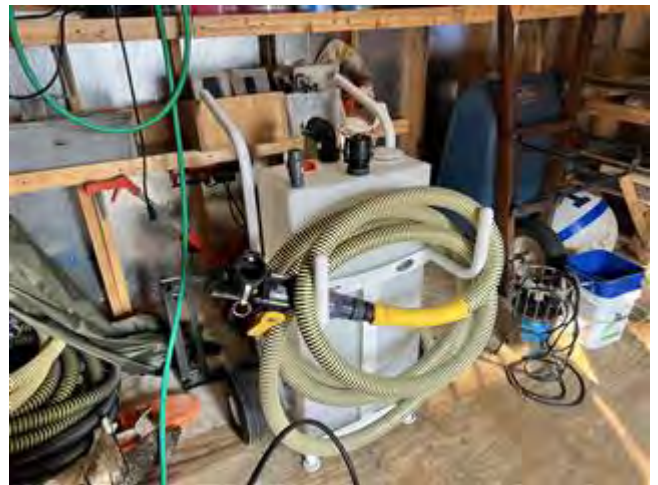
Sheds. The Association owns a shed used for maintenance/storage at the Deep Creek pier area. The shed is wood framed with vinyl siding and asphalt shingle roofing. The overall condition of the shed appears to be good.

We have assumed that components of the shed exterior will be replaced as needed and that when the shed is replaced, it will be replaced with a similar type and size shed.
